RE: SPRINGFIELD TOWNSHIP MUNICIPAL CAMPUS MASTER PLAN

VITETTA Architects and Engineers is proud to forward our summary report and recommendations for the Springfield Township Municipal Campus Master Plan. This report summarizes our work with the Township and the Advisory Committee to review the previously prepared plan and help developed a consensus plan for how best to meet the now and future needs of the Township government and its ability to provide services to the Township.

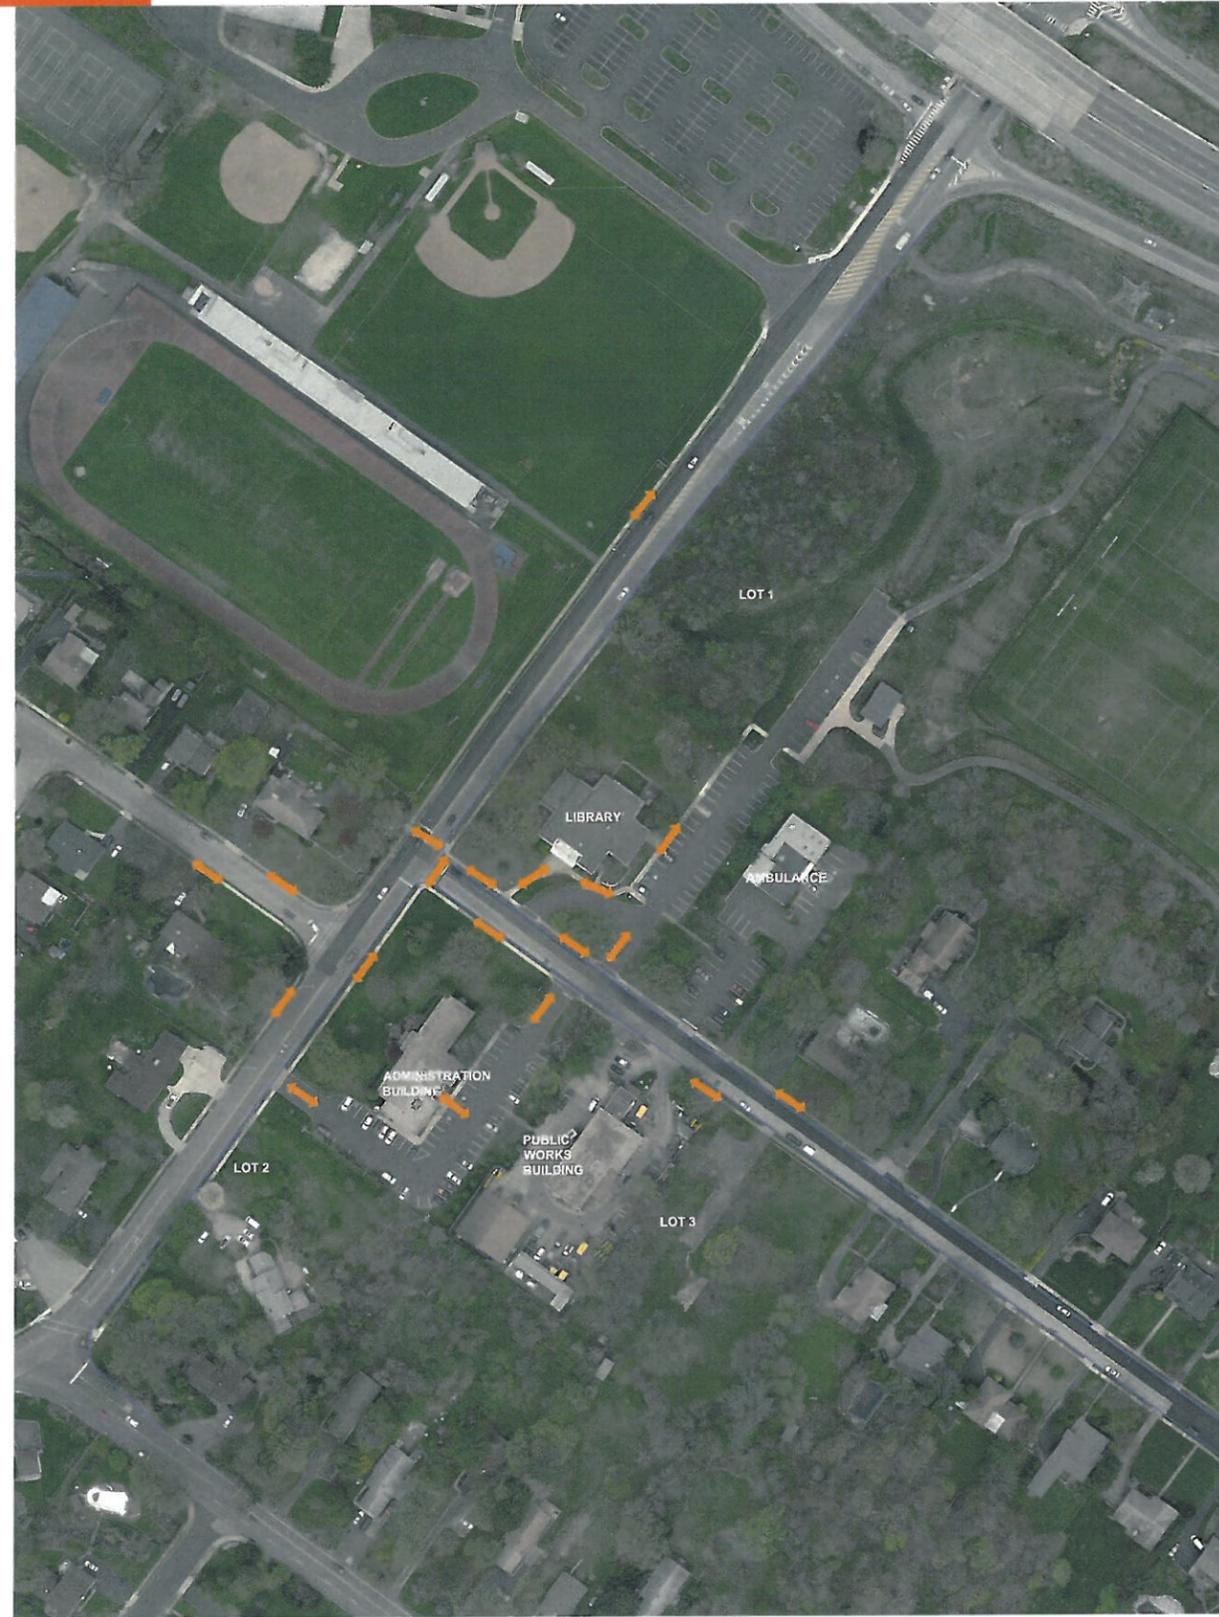
**PEDESTRIAN & VEHICLE
CIRCULATION**

***arrows indicate primary
pedestrian and vehicular
directions**

Very little on-site pedestrian circulation occurs, other than that resulting from a need for additional event parking for the Library or for the Meeting Room at the Administration Building. Proposed design should separate pedestrian and vehicular traffic to the maximum extent possible to encourage shared used of parking and allow an overall reduction in on-site parking.

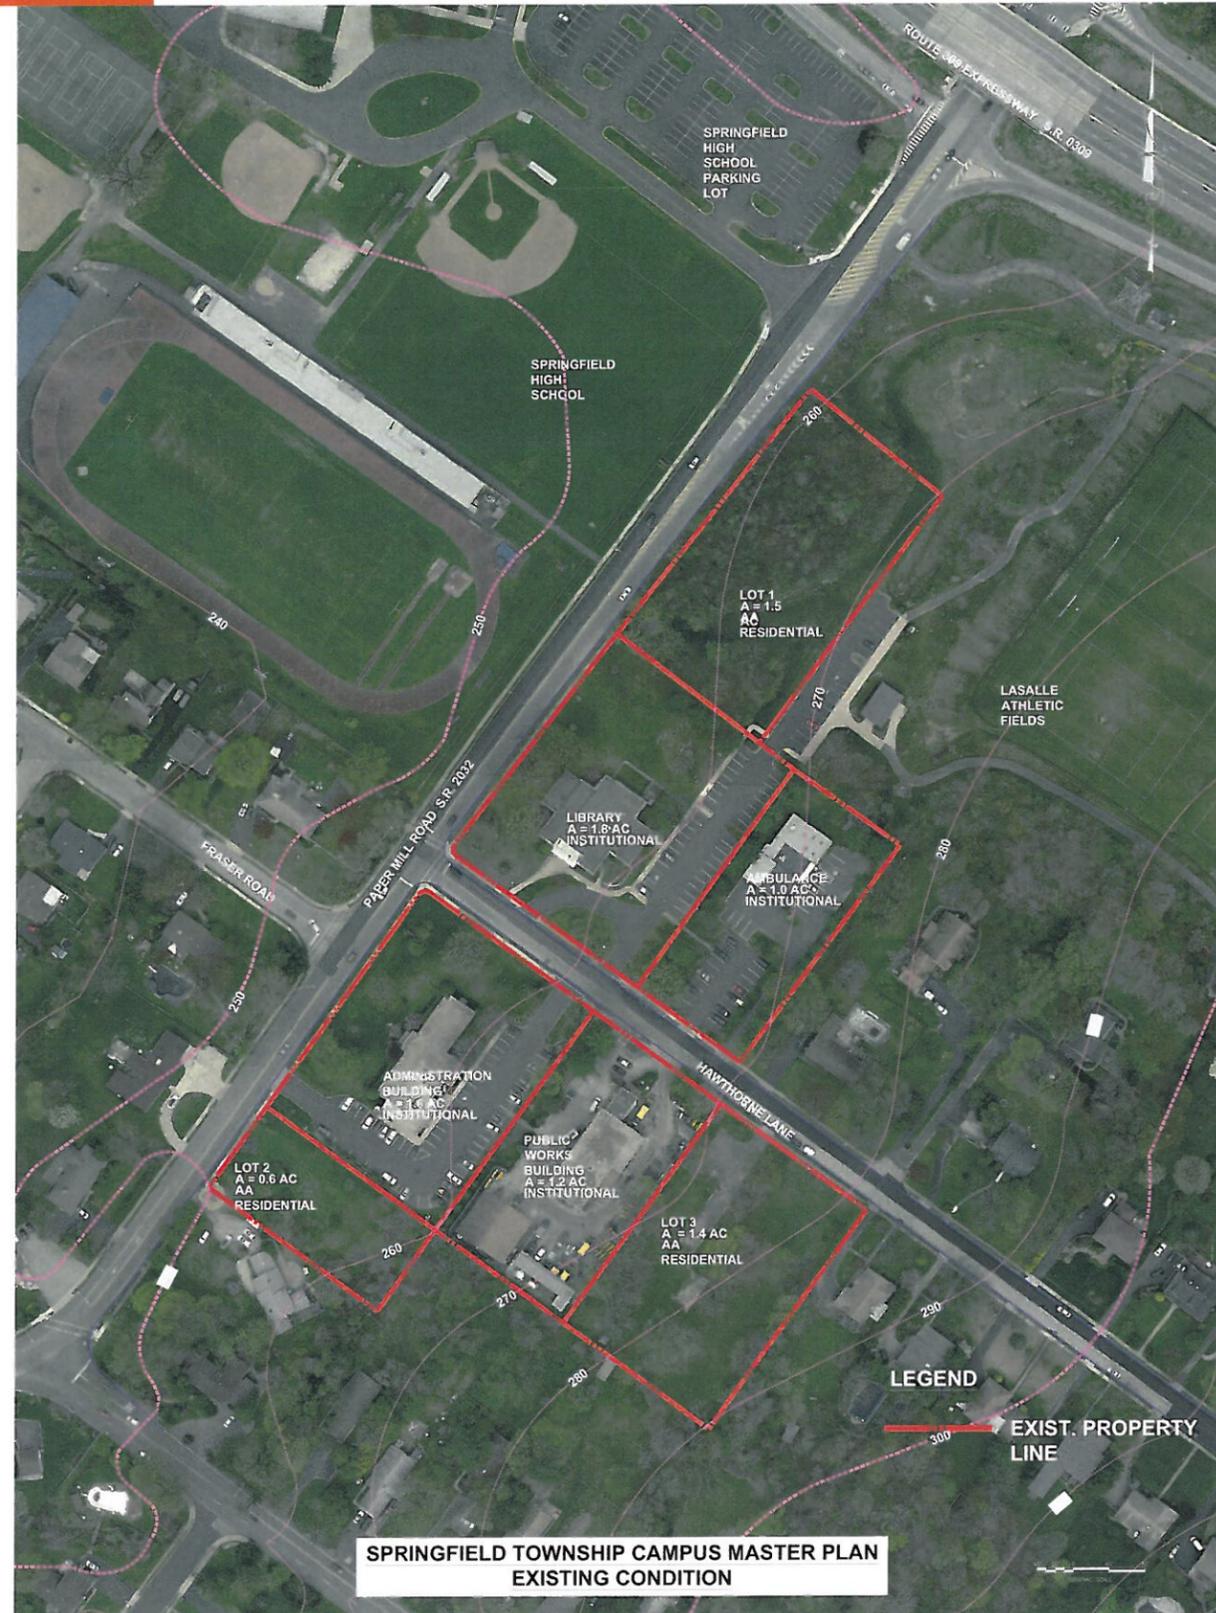
**PROPERTY LINES
& LOT AREAS**

***boundary lines are
indicated in red**

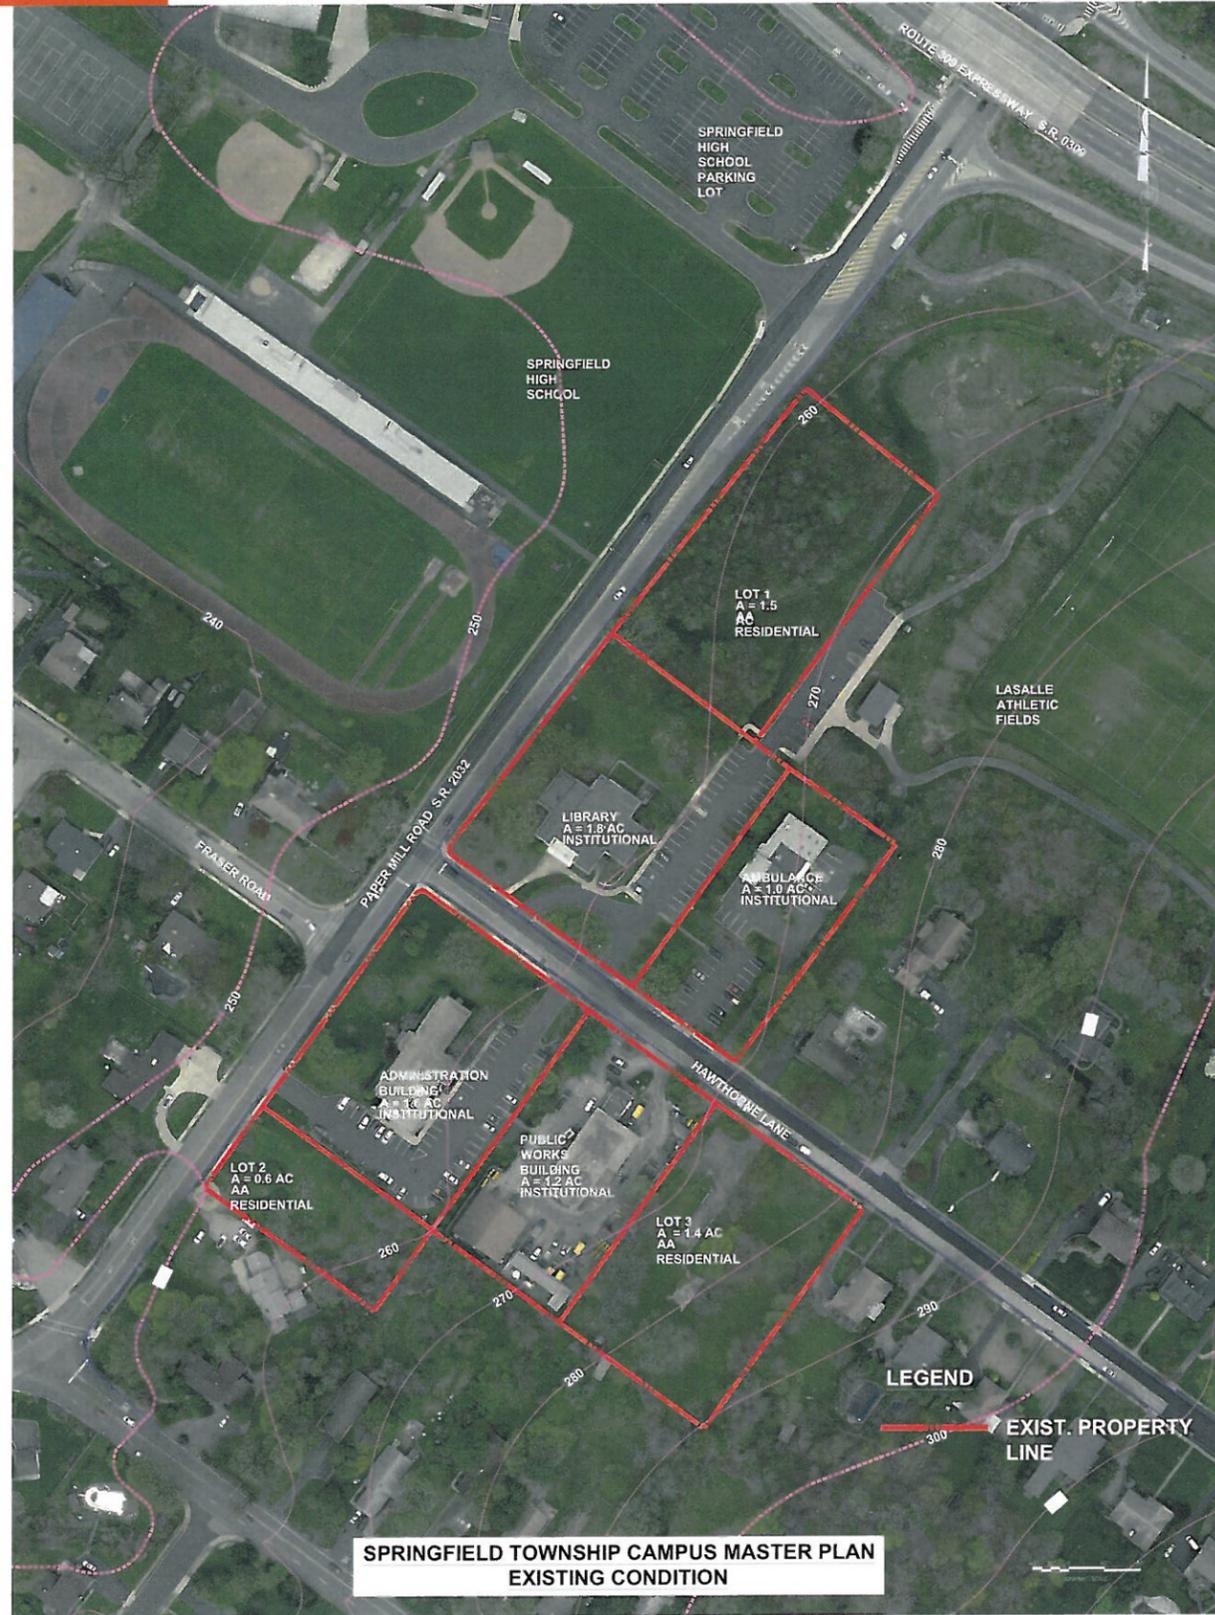
SPRINGFIELD TOWNSHIP CAMPUS MASTER PLAN
EXISTING CONDITION

**PEDESTRIAN TRAVEL
CORRIDORS**

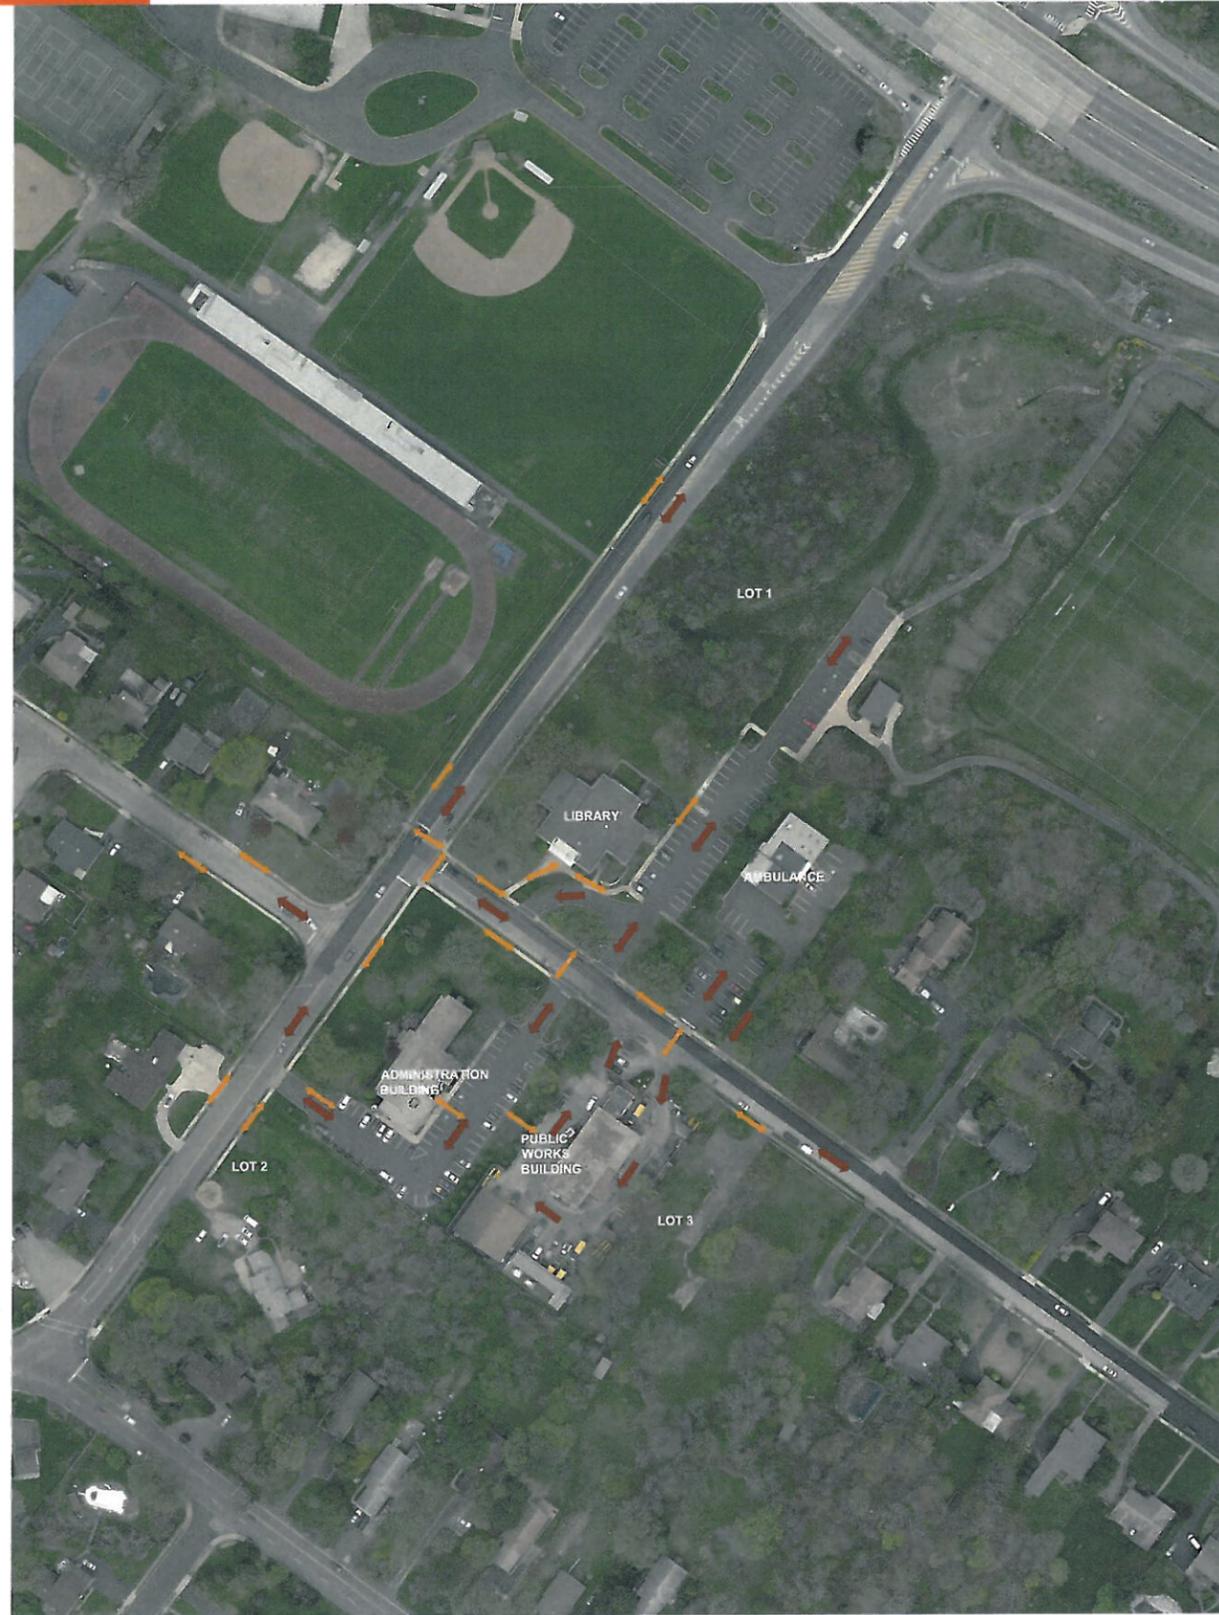
**VEHICULAR TRAFFIC
CIRCULATION**

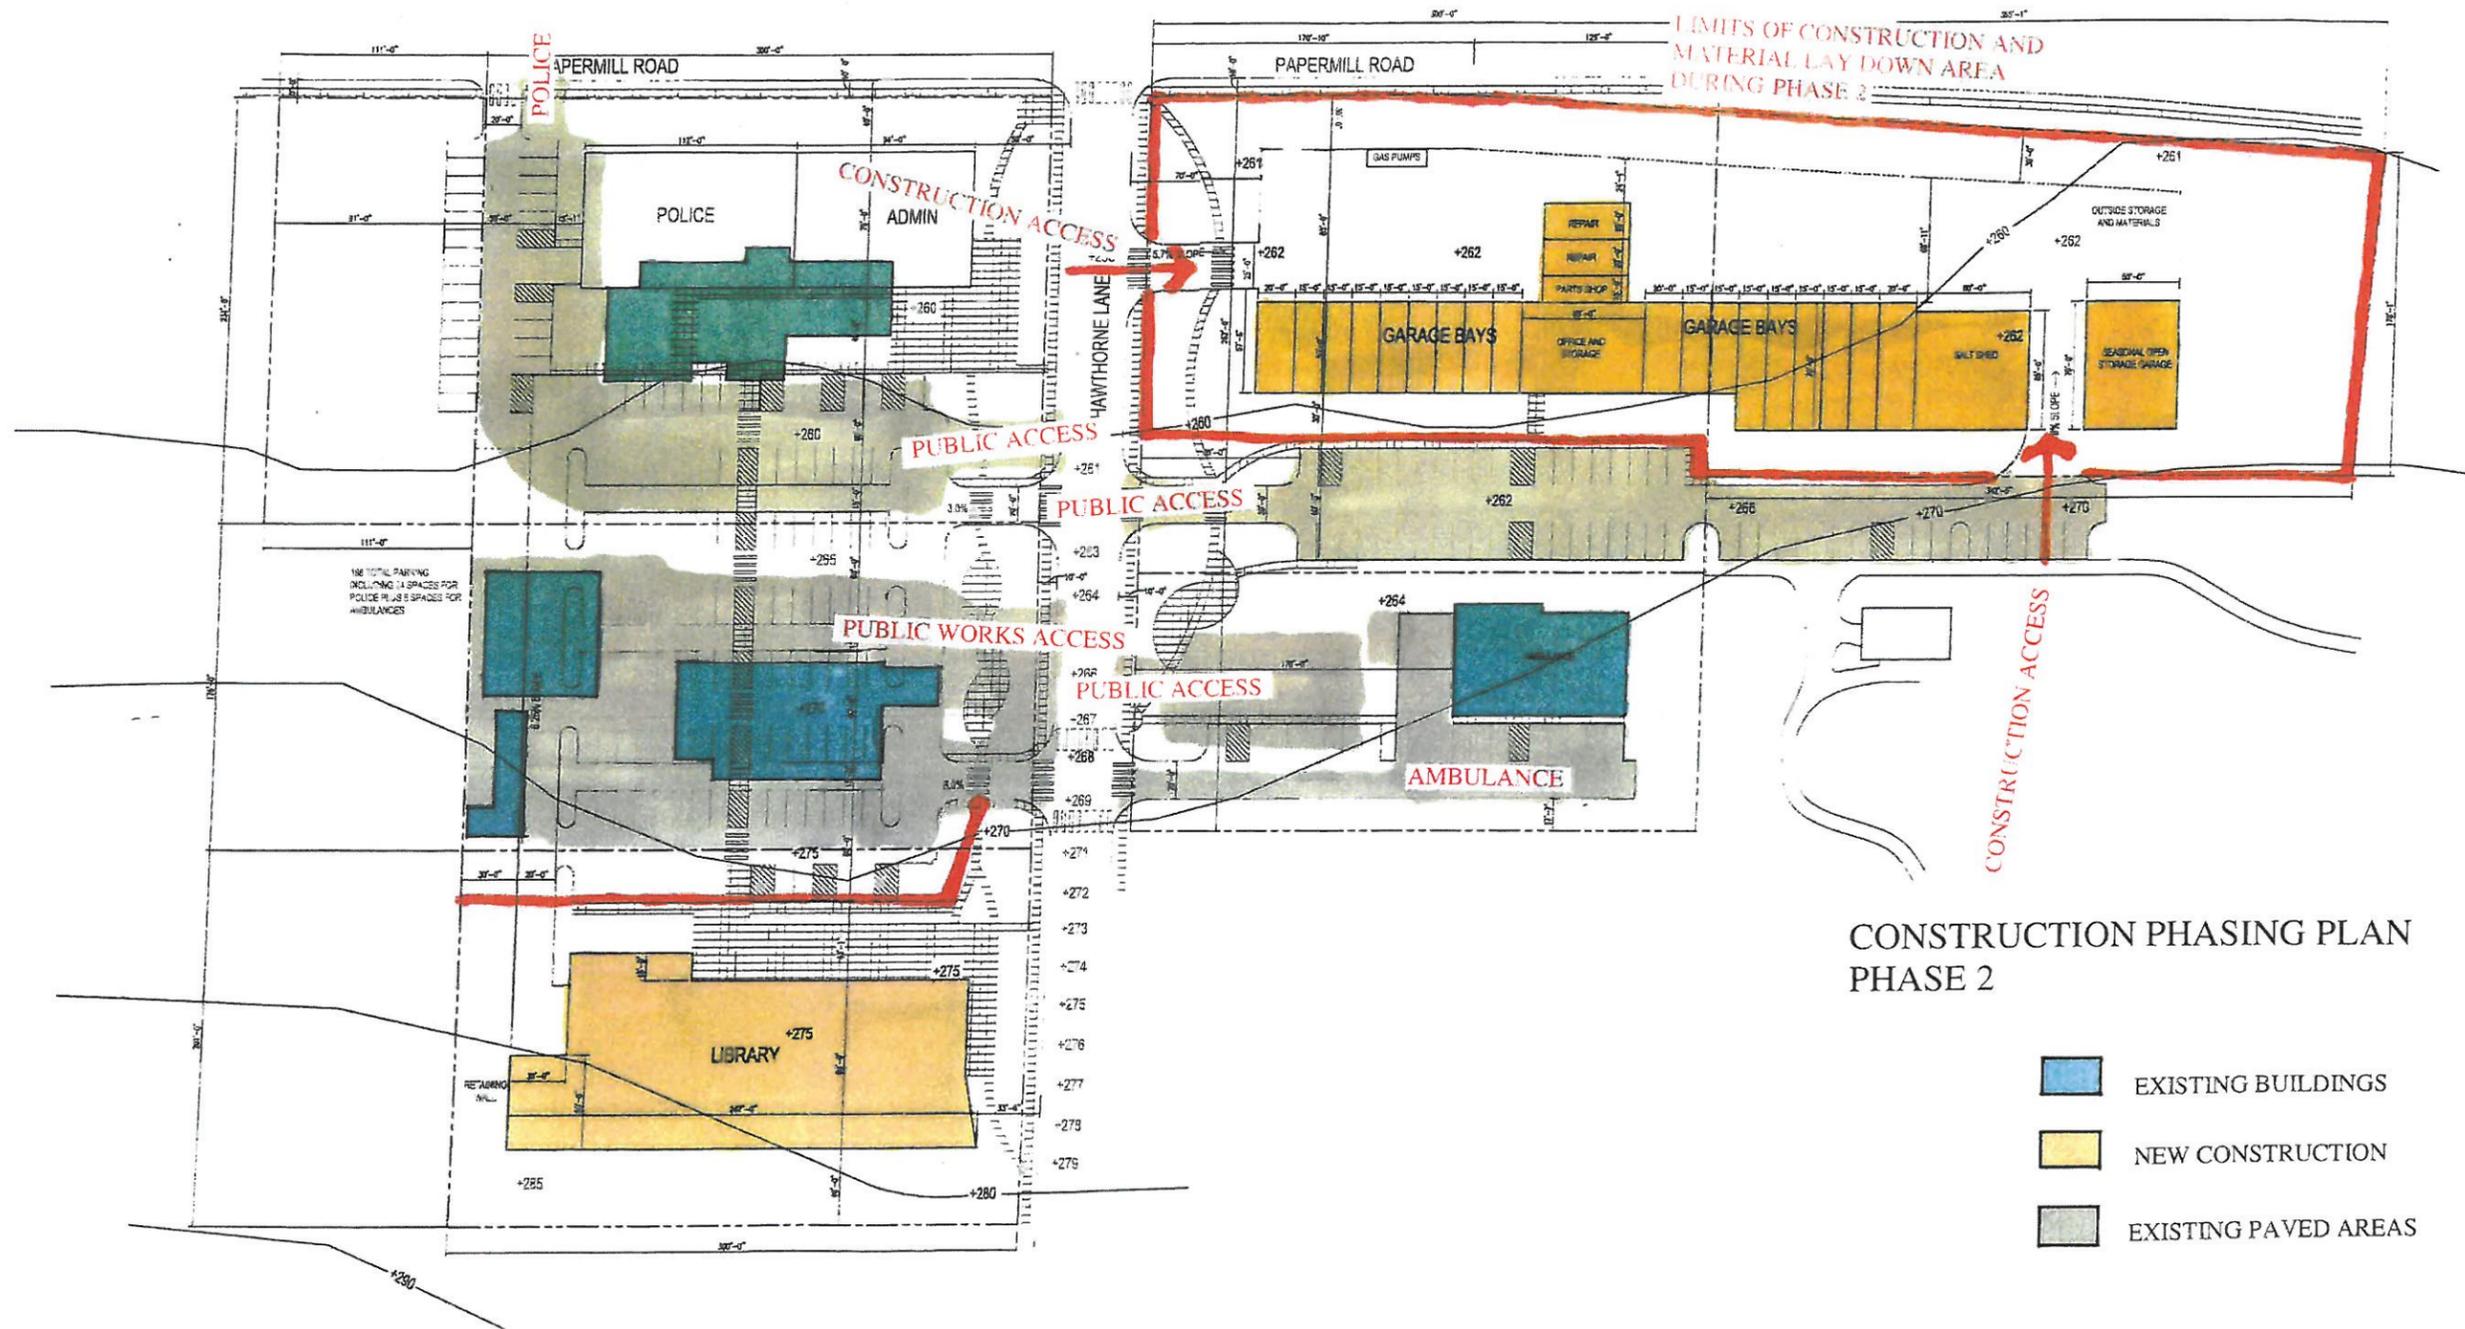
CONSTRUCTION PHASING PLAN
PHASE 2

- EXISTING BUILDINGS
- NEW CONSTRUCTION
- EXISTING PAVED AREAS

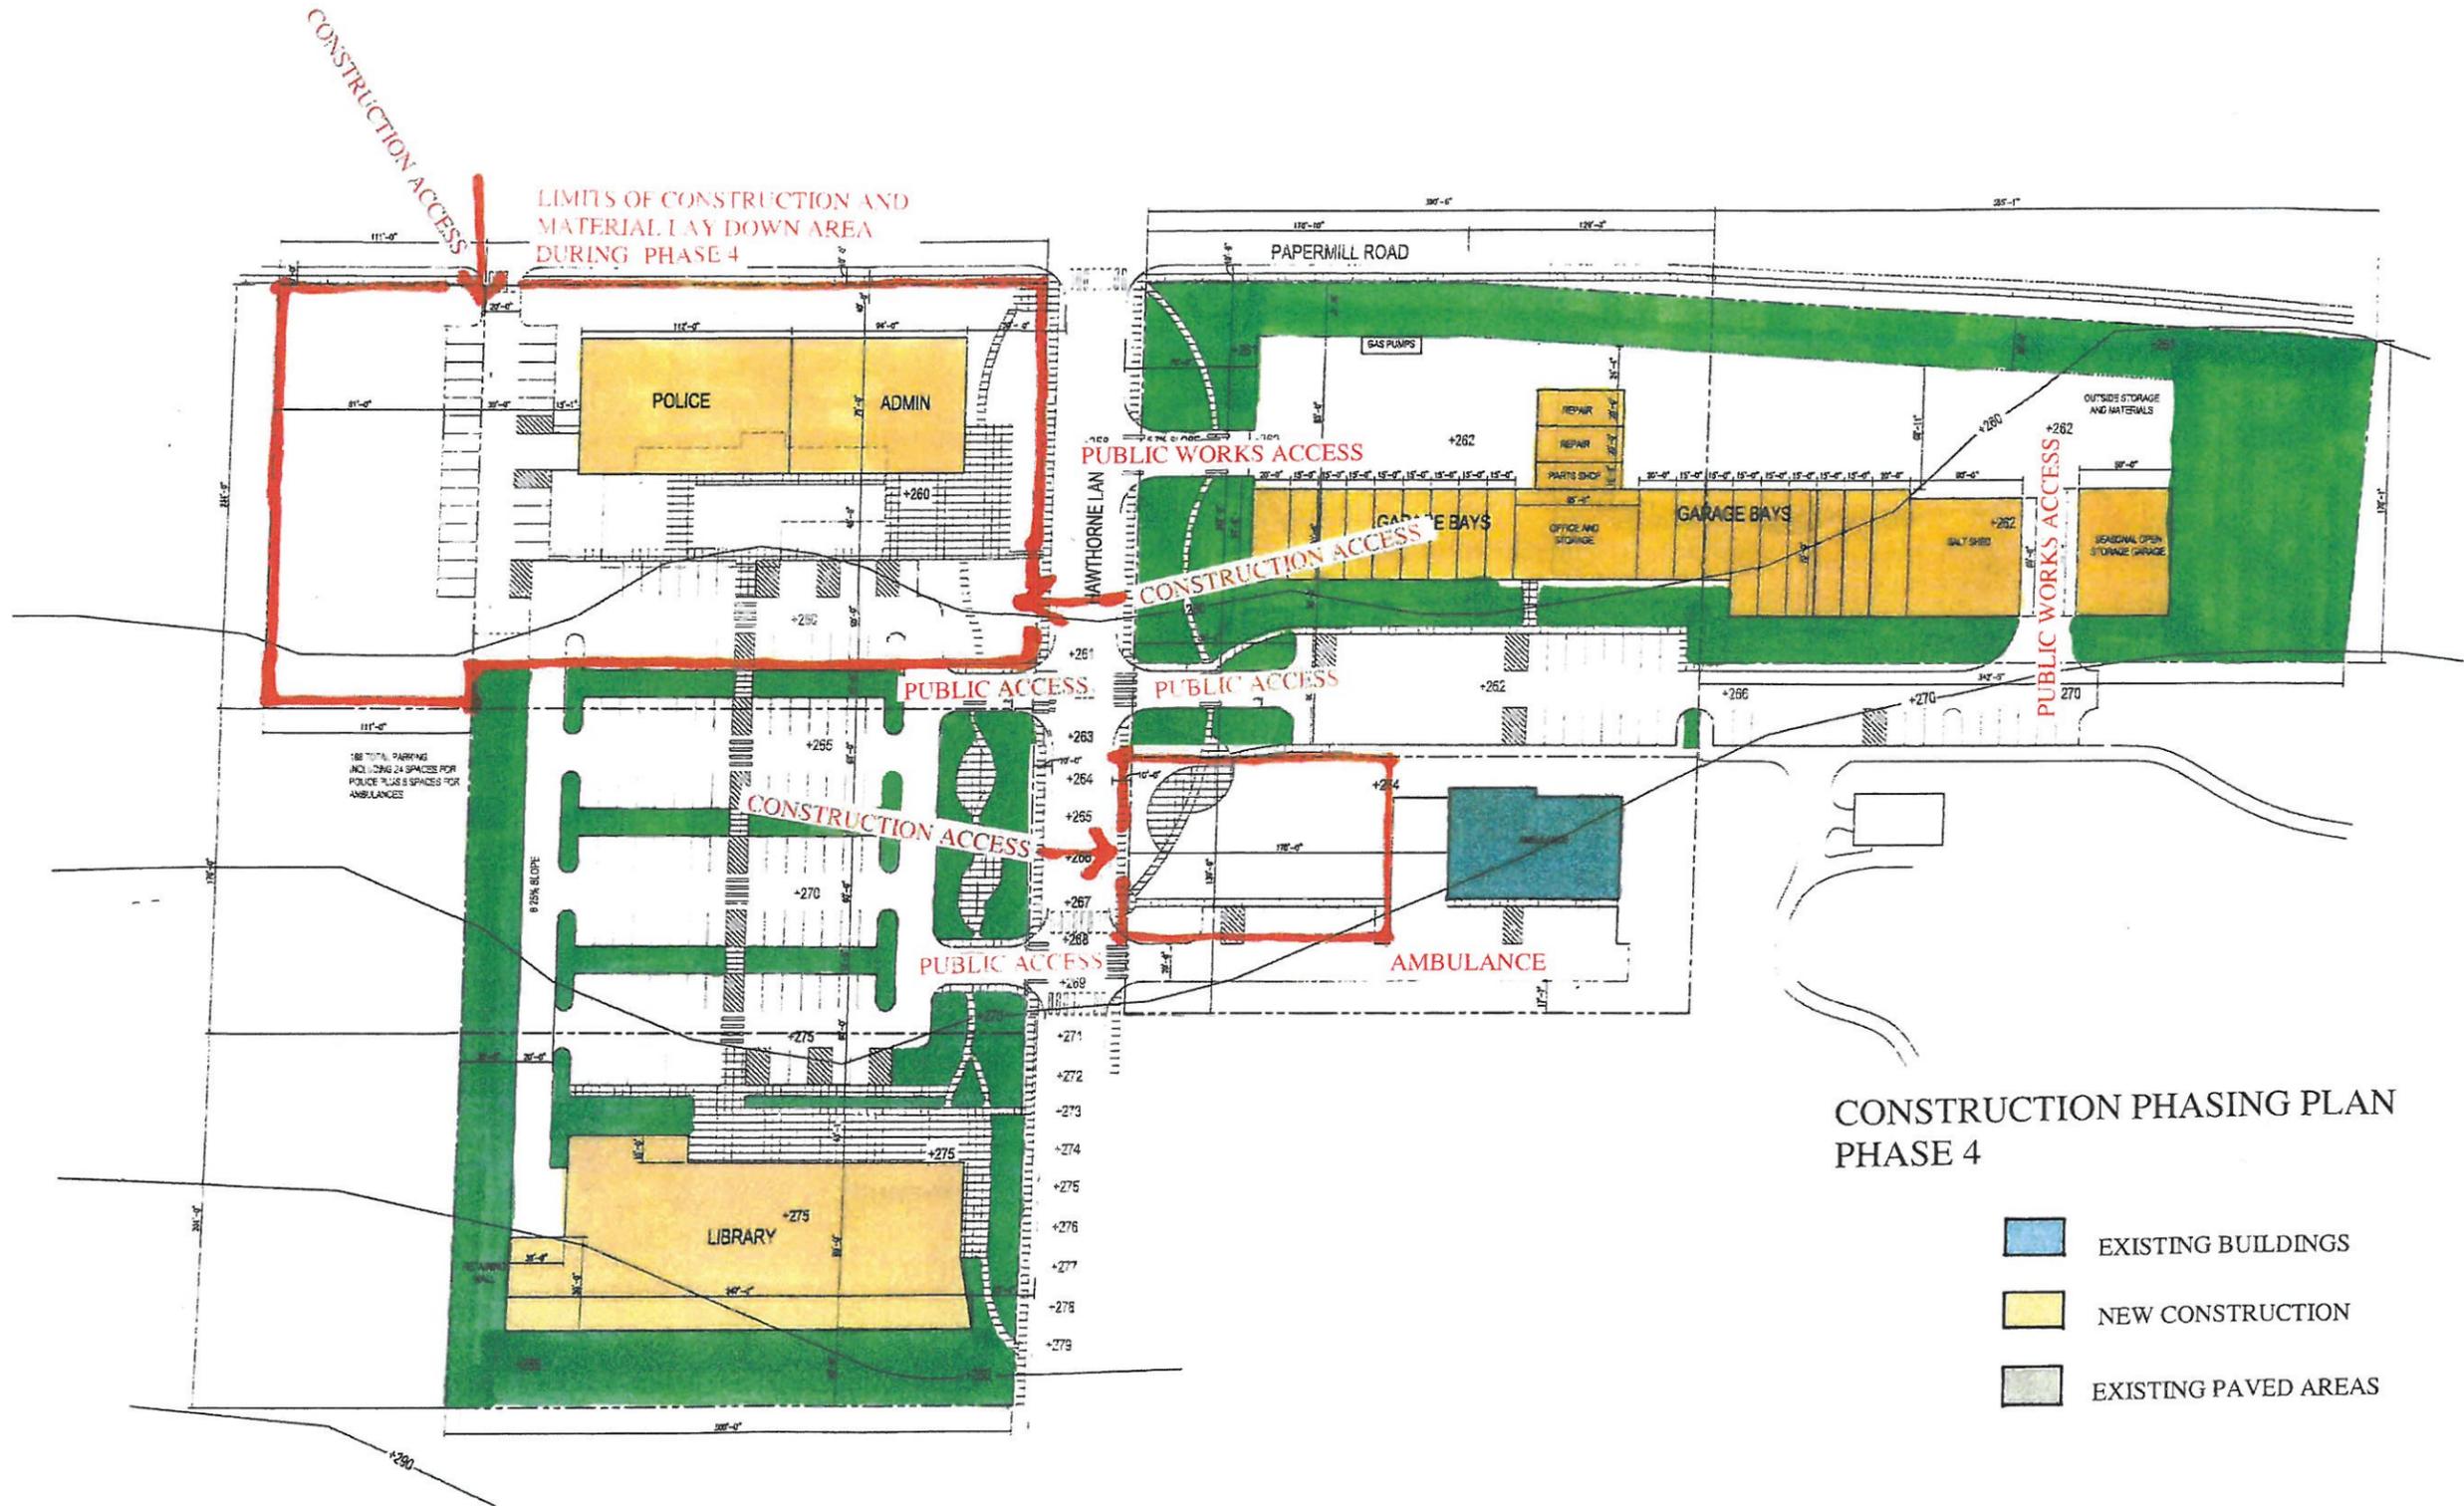
CONSTRUCTION PHASING PLAN
PHASE 4

- EXISTING BUILDINGS
- NEW CONSTRUCTION
- EXISTING PAVED AREAS

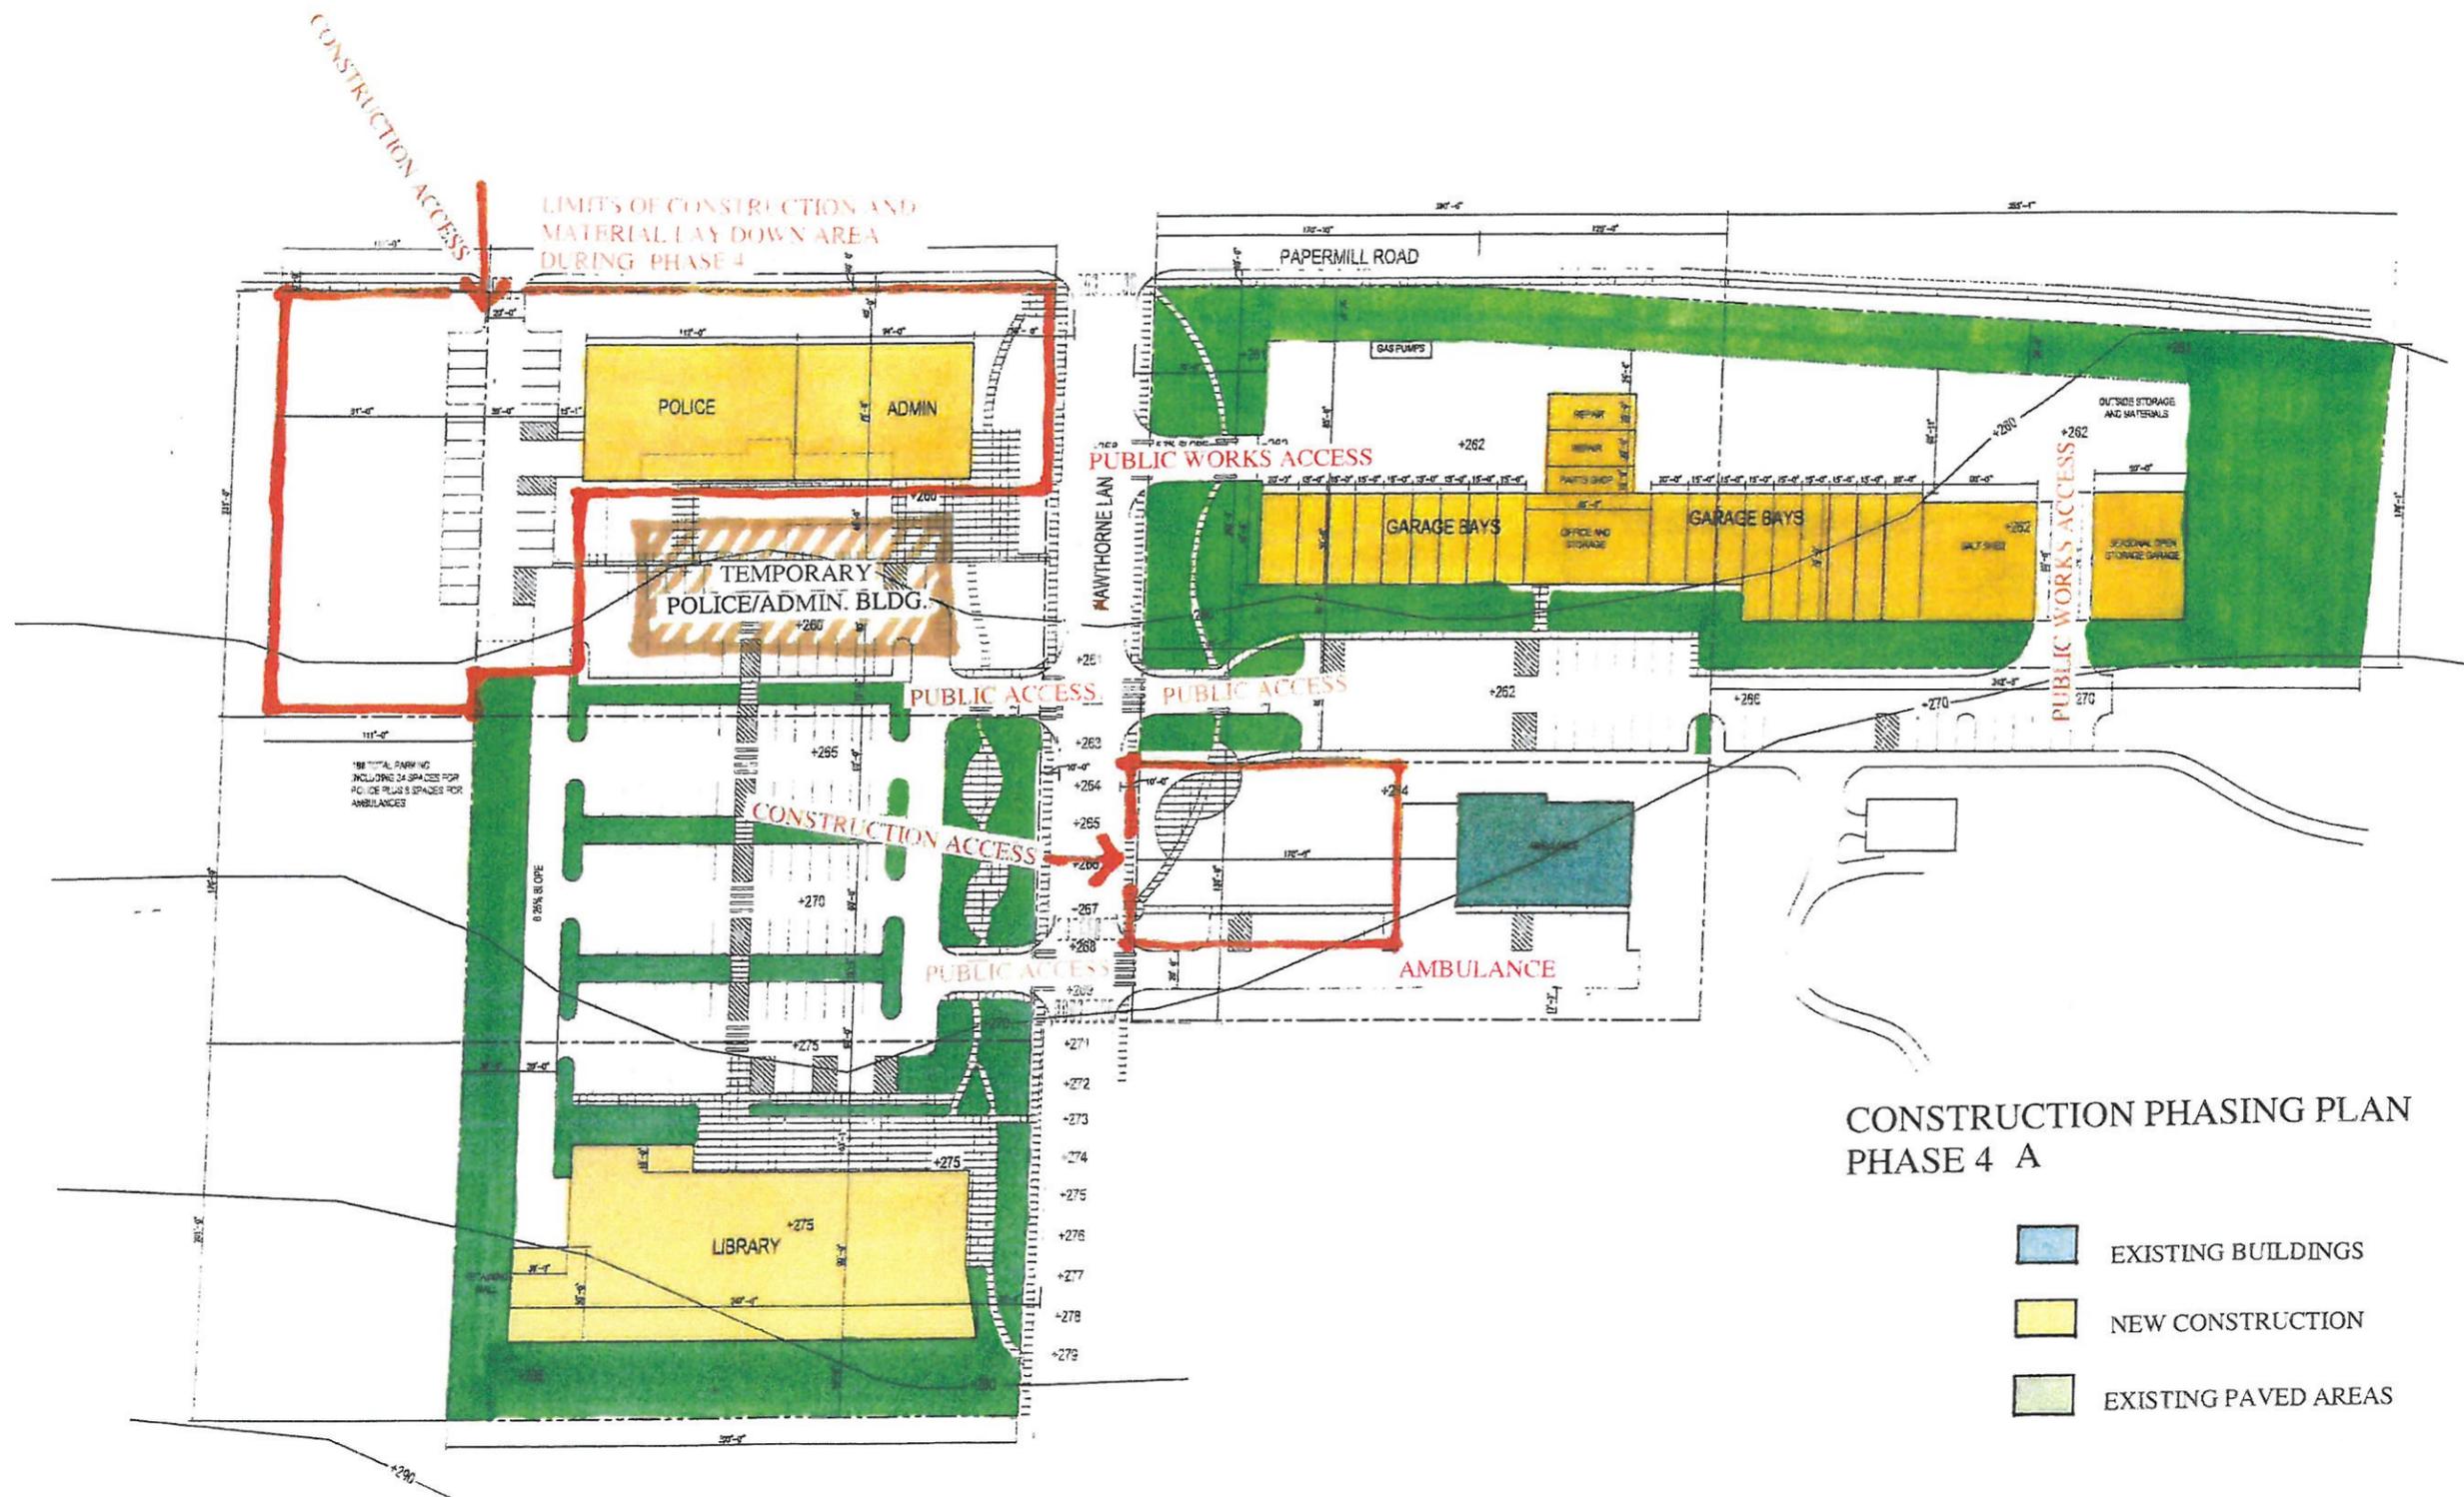
CONSTRUCTION PHASING PLAN
PHASE 4 A

- EXISTING BUILDINGS
- NEW CONSTRUCTION
- EXISTING PAVED AREAS

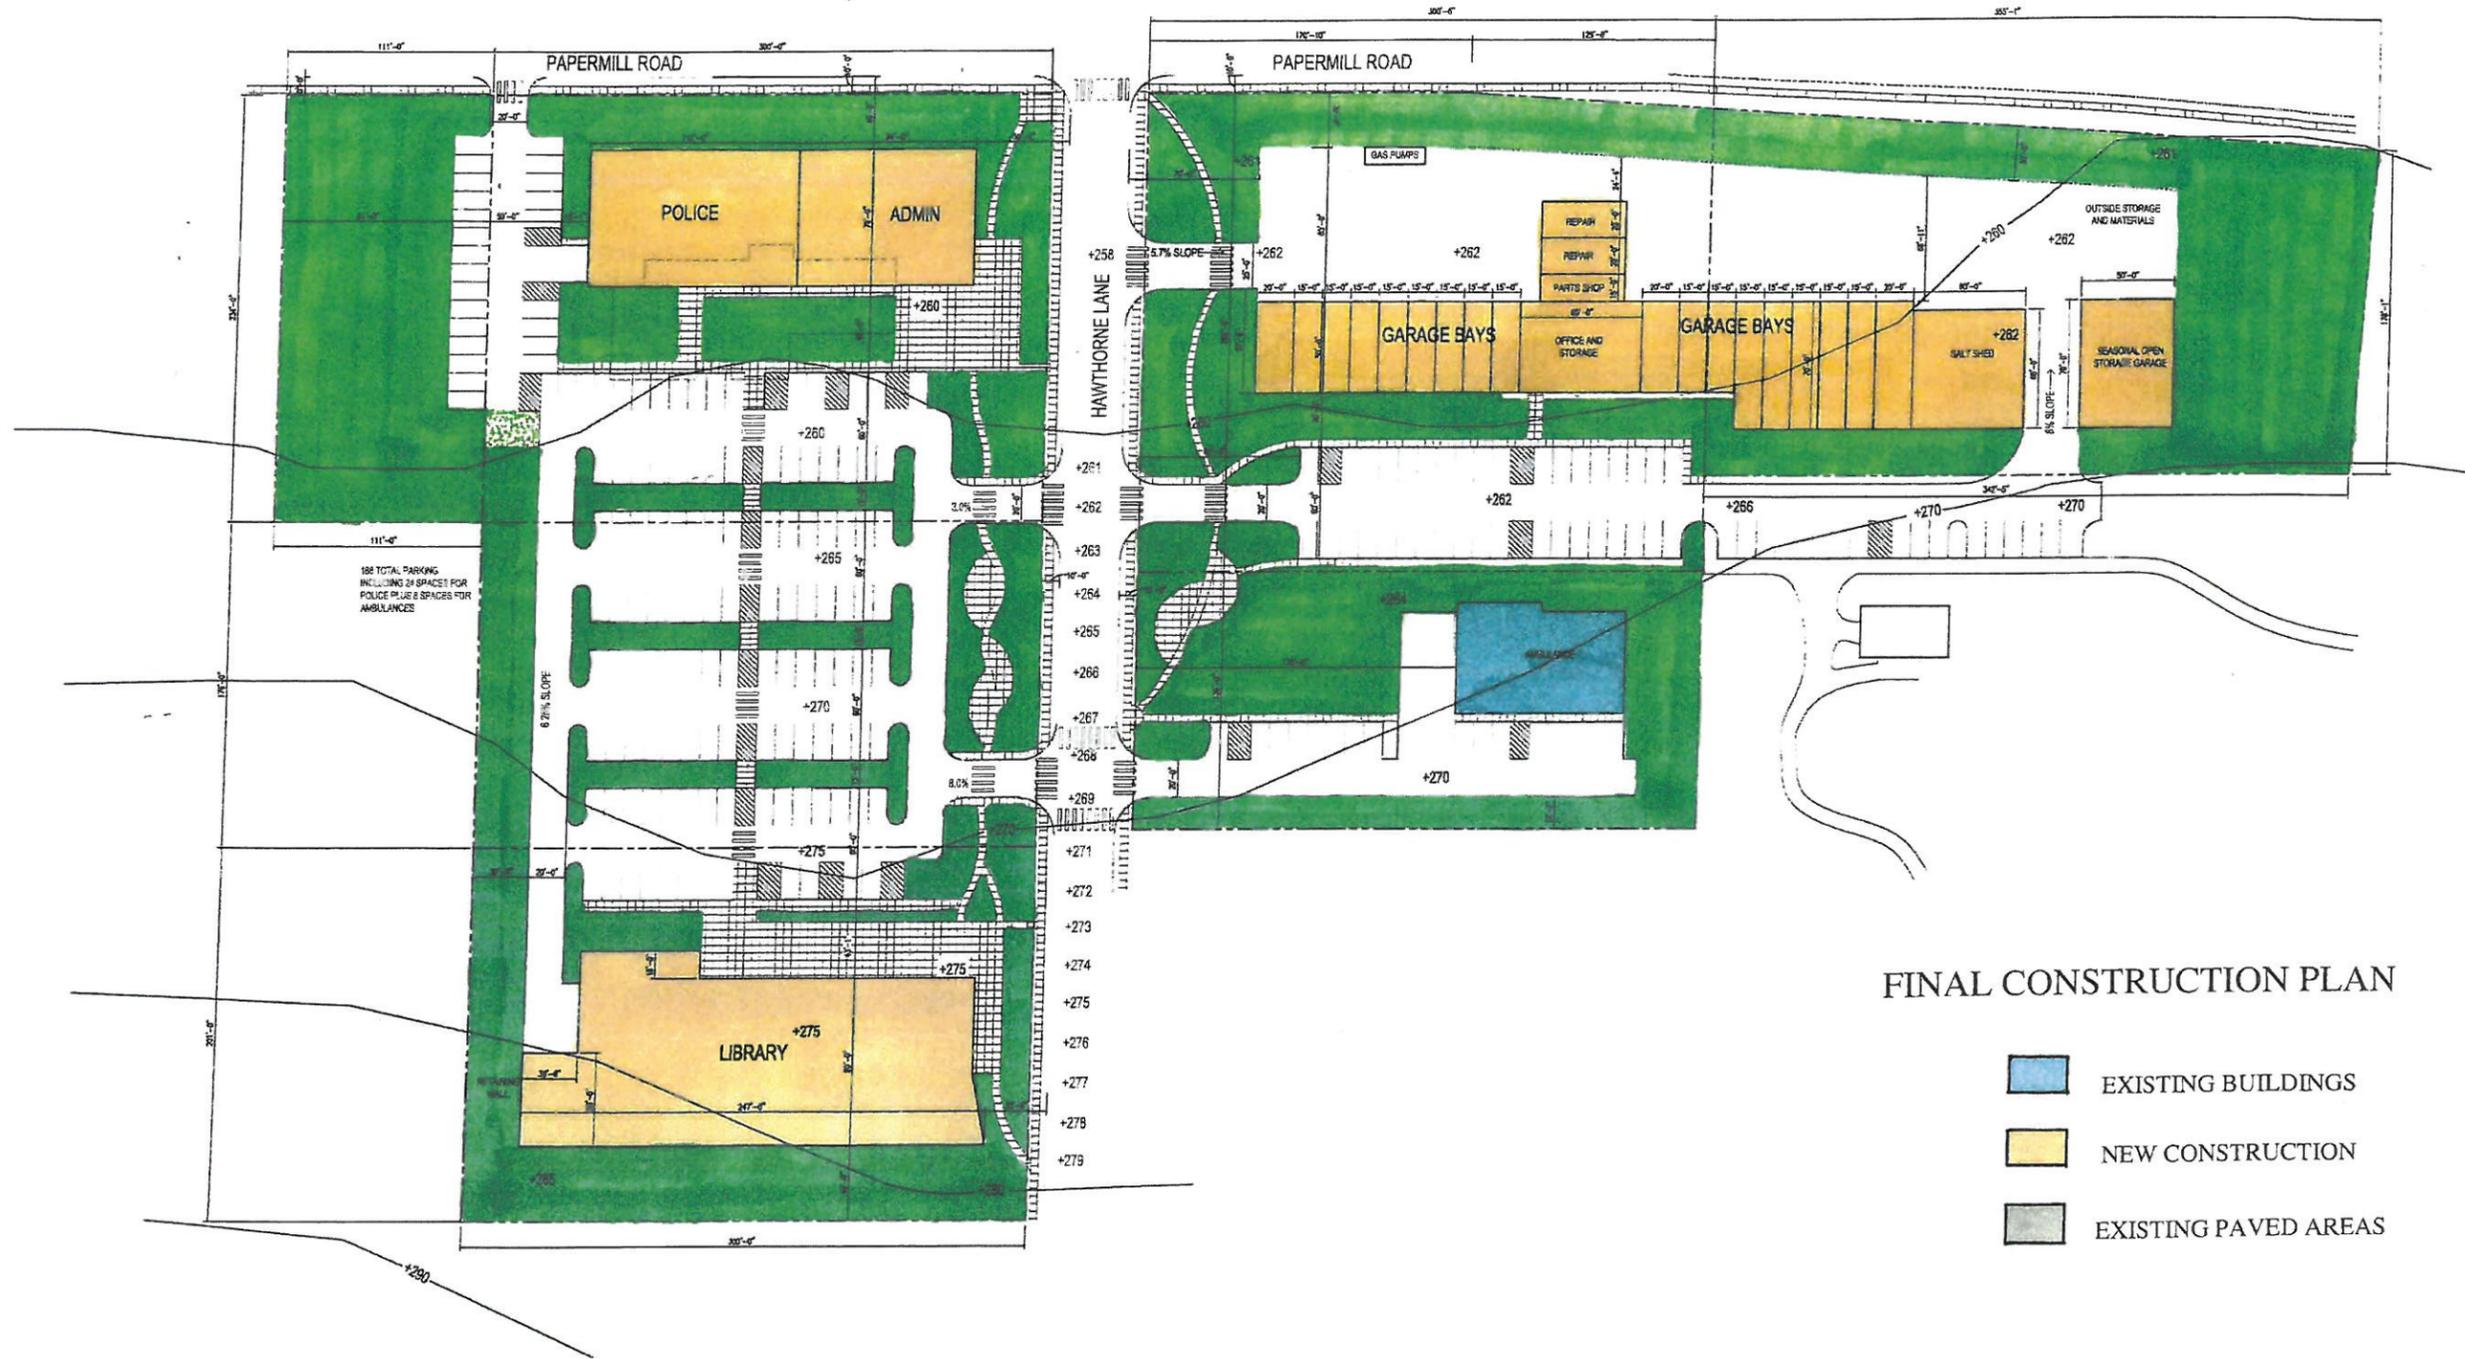
FINAL CONSTRUCTION PLAN

All construction is completed. The buildings have all been completed and the sitework is also complete.
