RE: SPRINGFIELD TOWNSHIP MUNICIPAL CAMPUS MASTER PLAN

VITETTA Architects and Engineers is proud to forward our summary report and recommendations for the Springfield Township Municipal Campus Master Plan. This report summarizes our work with the Township and the Advisory Committee to review the previously prepared plan and help developed a consensus plan for how best to meet the now and future needs of the Township government and its ability to provide services to the Township.

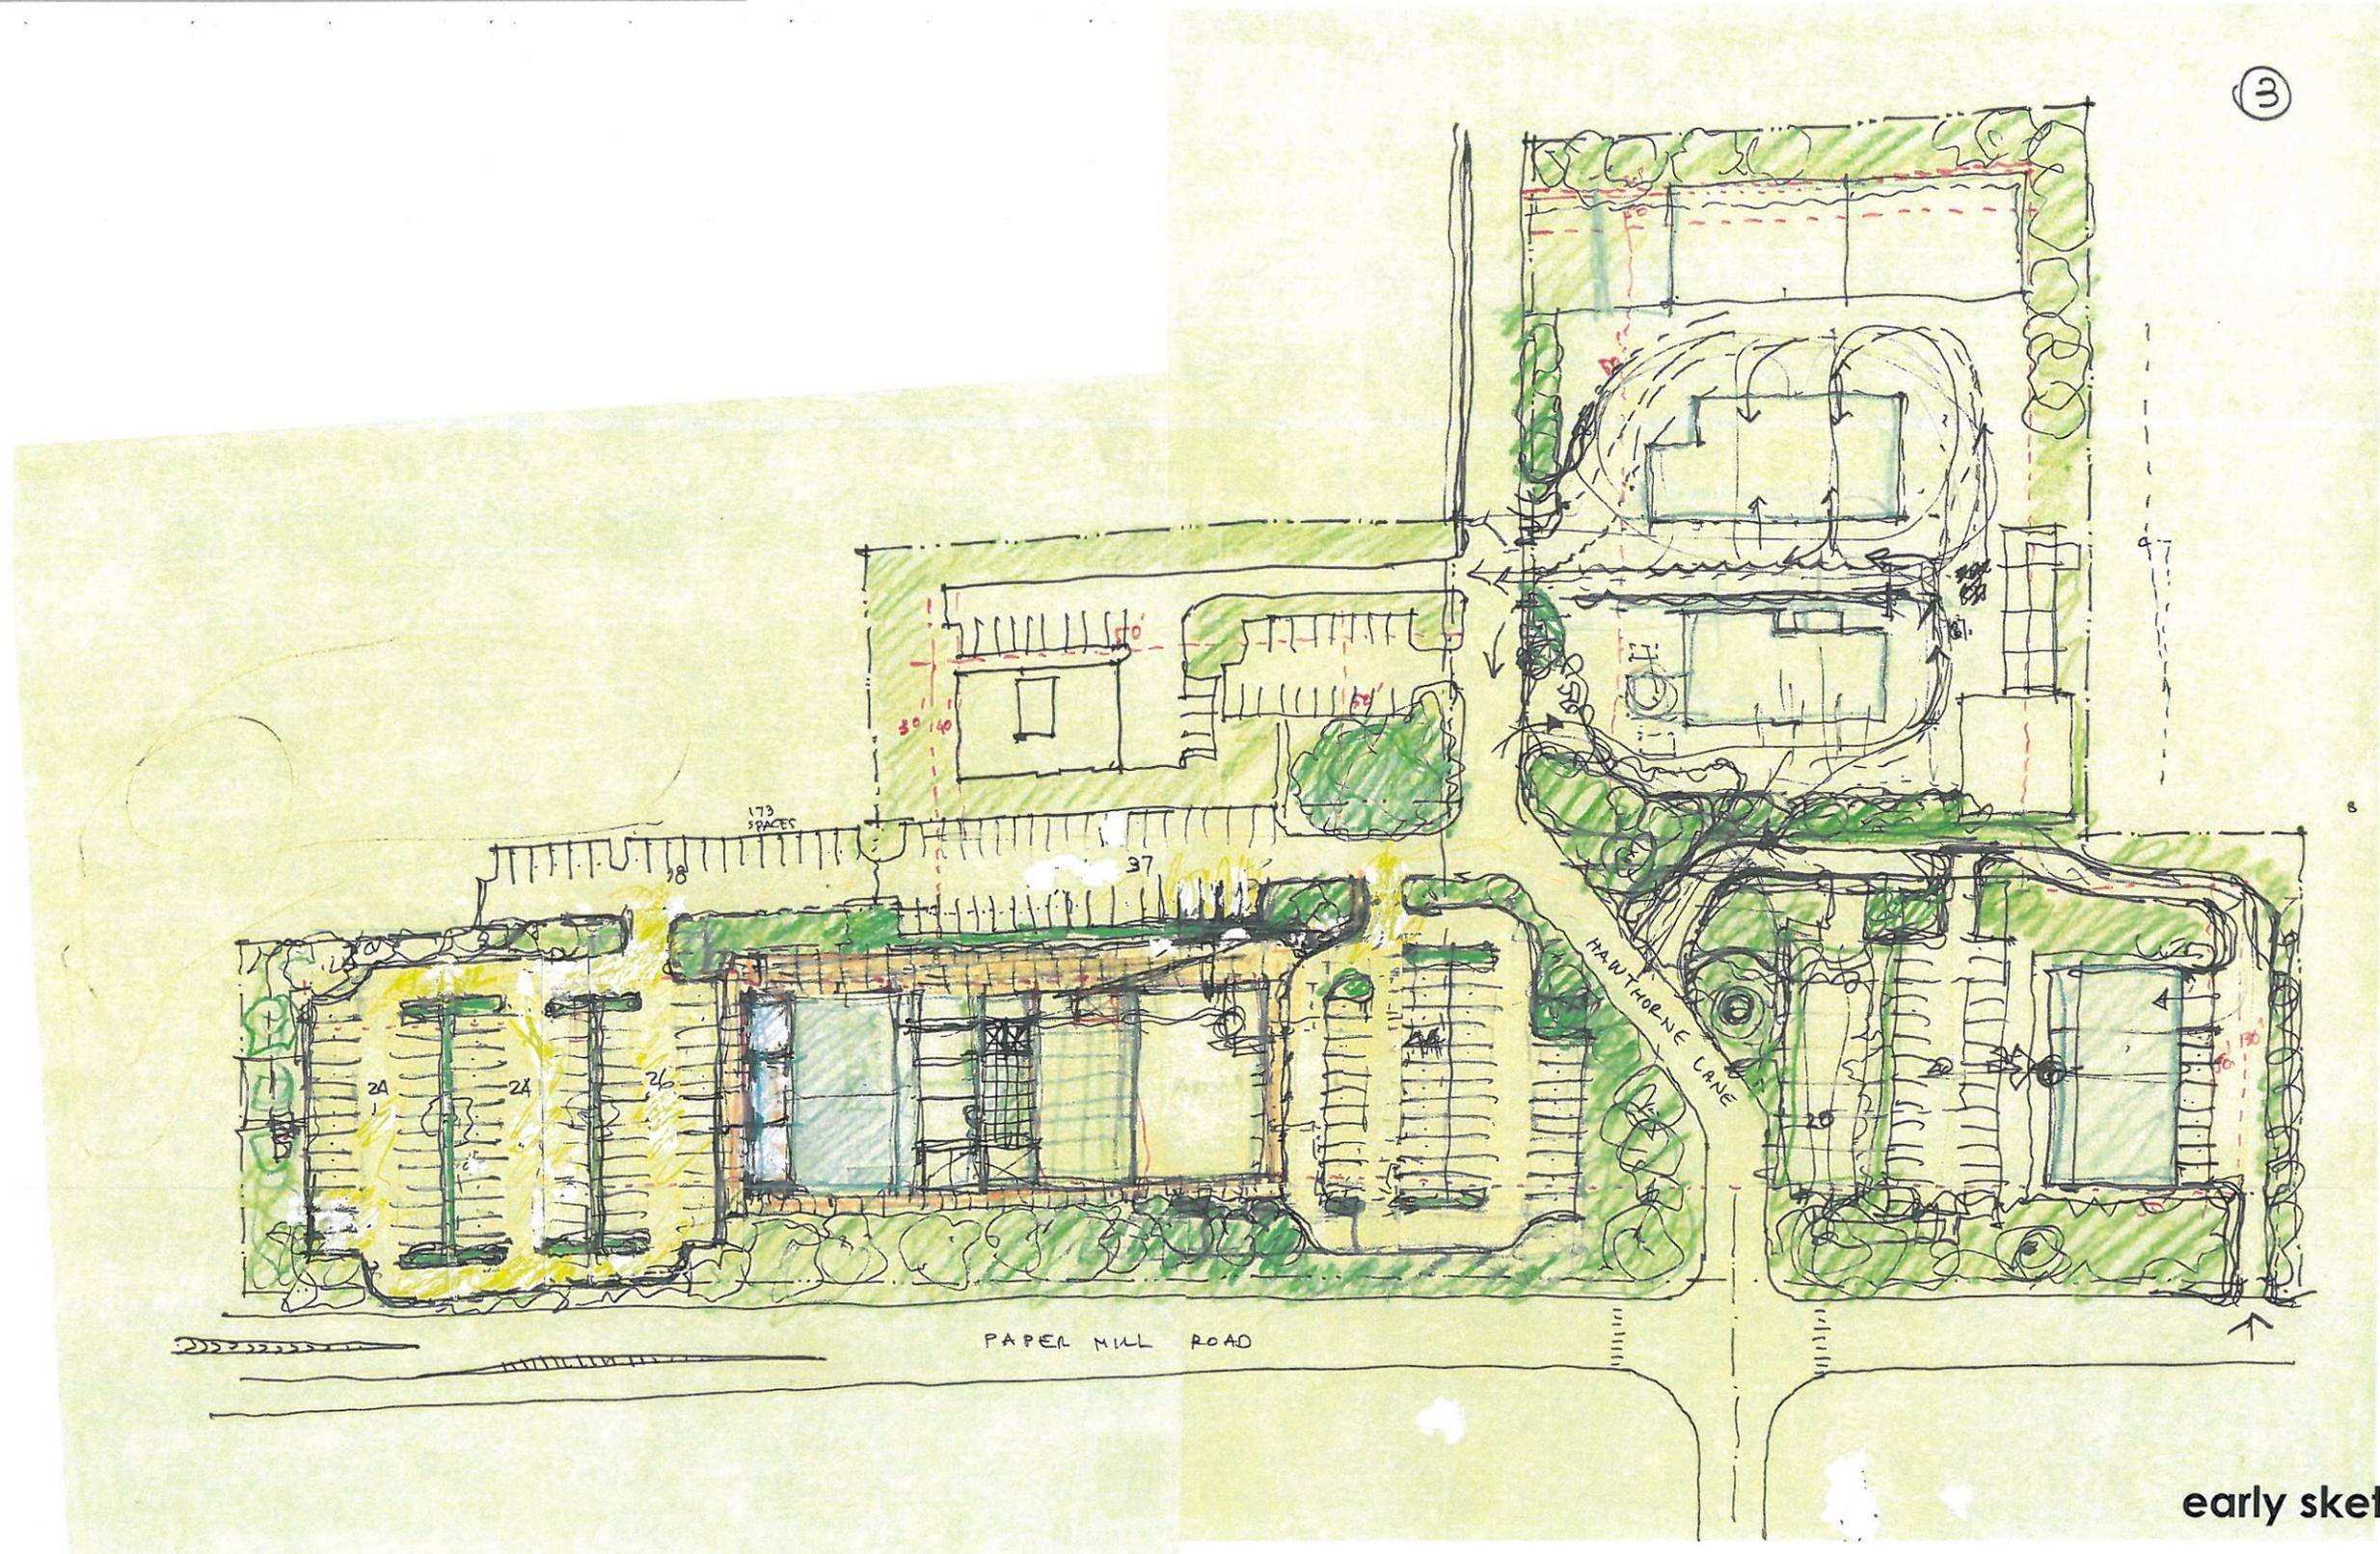
early sketch 3

3 In this concept, Hawthorne Lane is re-aligned. Police and Public works are located in the southern section, with a separate access from Paper Mill Road close to the location of the current police driveway. Public Works stays where it had been and enlarged. The building for the administration, library and community space could be configured in many ways, including using multiple stories to reduce the footprint size. It enhances the use of shared parking. The difference between Concept 4 and 4 A is the final location of the library, the Community Building and the administration relative to one another. Concept 4 is as shown, in Concept 4A, the Community Center is adjacent to the administration section and parking is at the farthest point of the site.

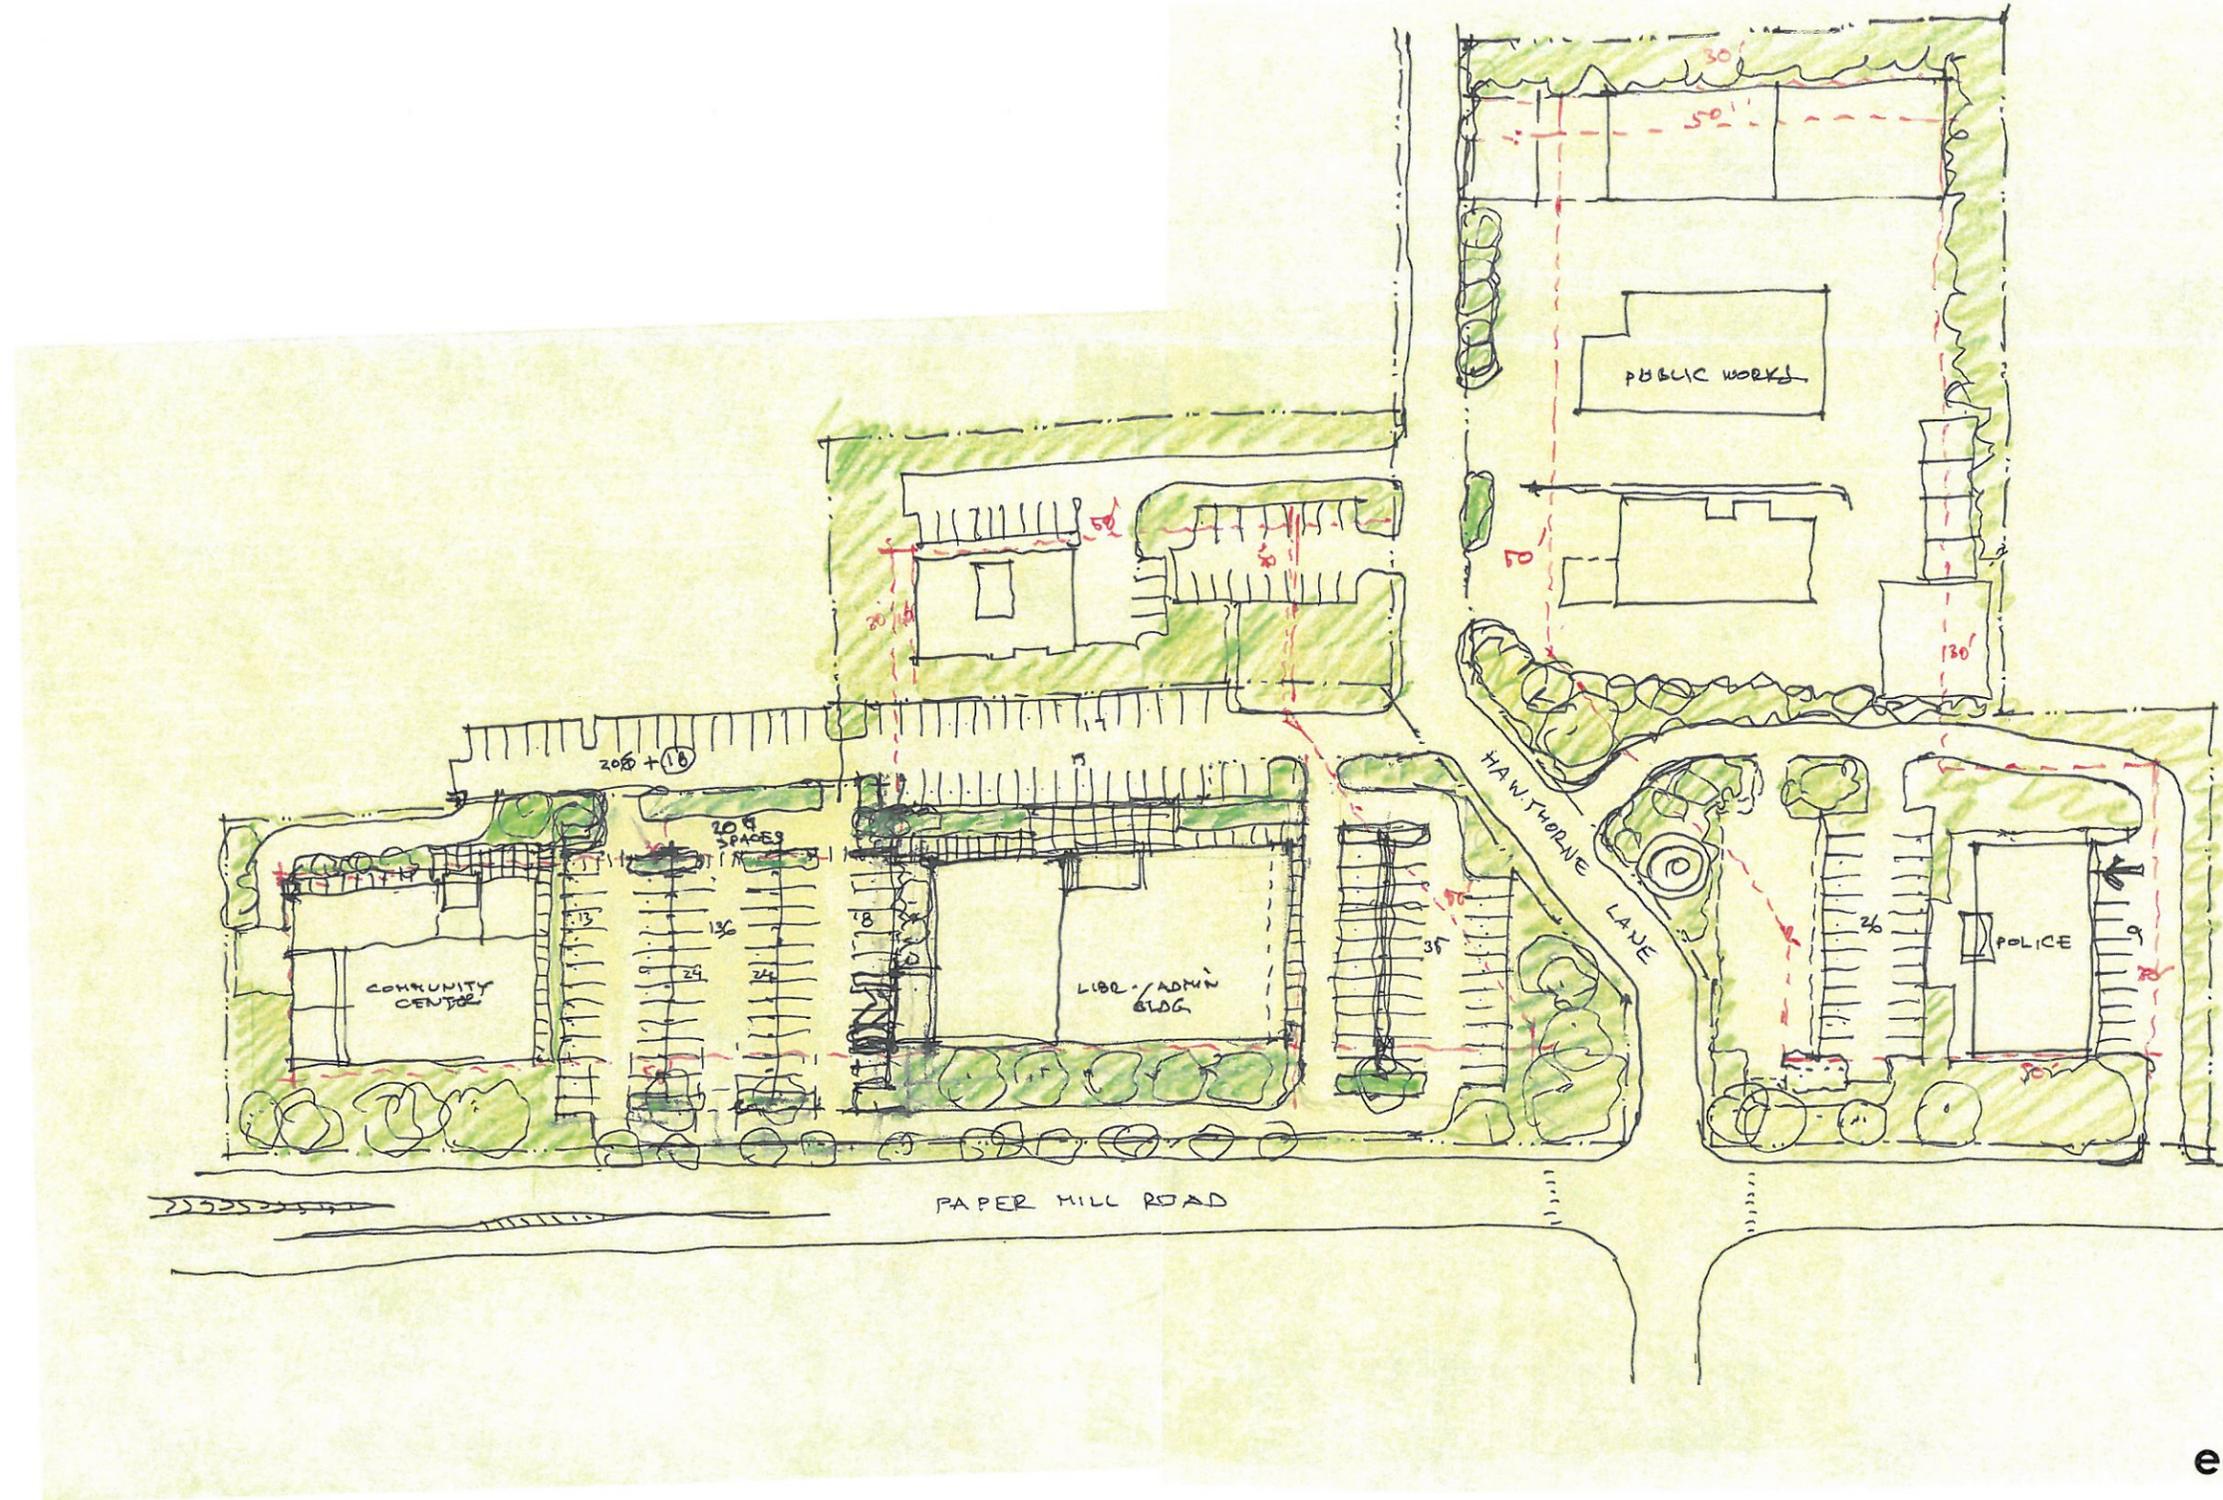
early sketch 4

4 In Concept 4, Hawthorne lane is again relocated. Public Works remains in its current location and is enlarged to its program need. The Police are in a separate building on Paper Mill Road and the other uses are grouped together on the library side of Hawthorne Lane.

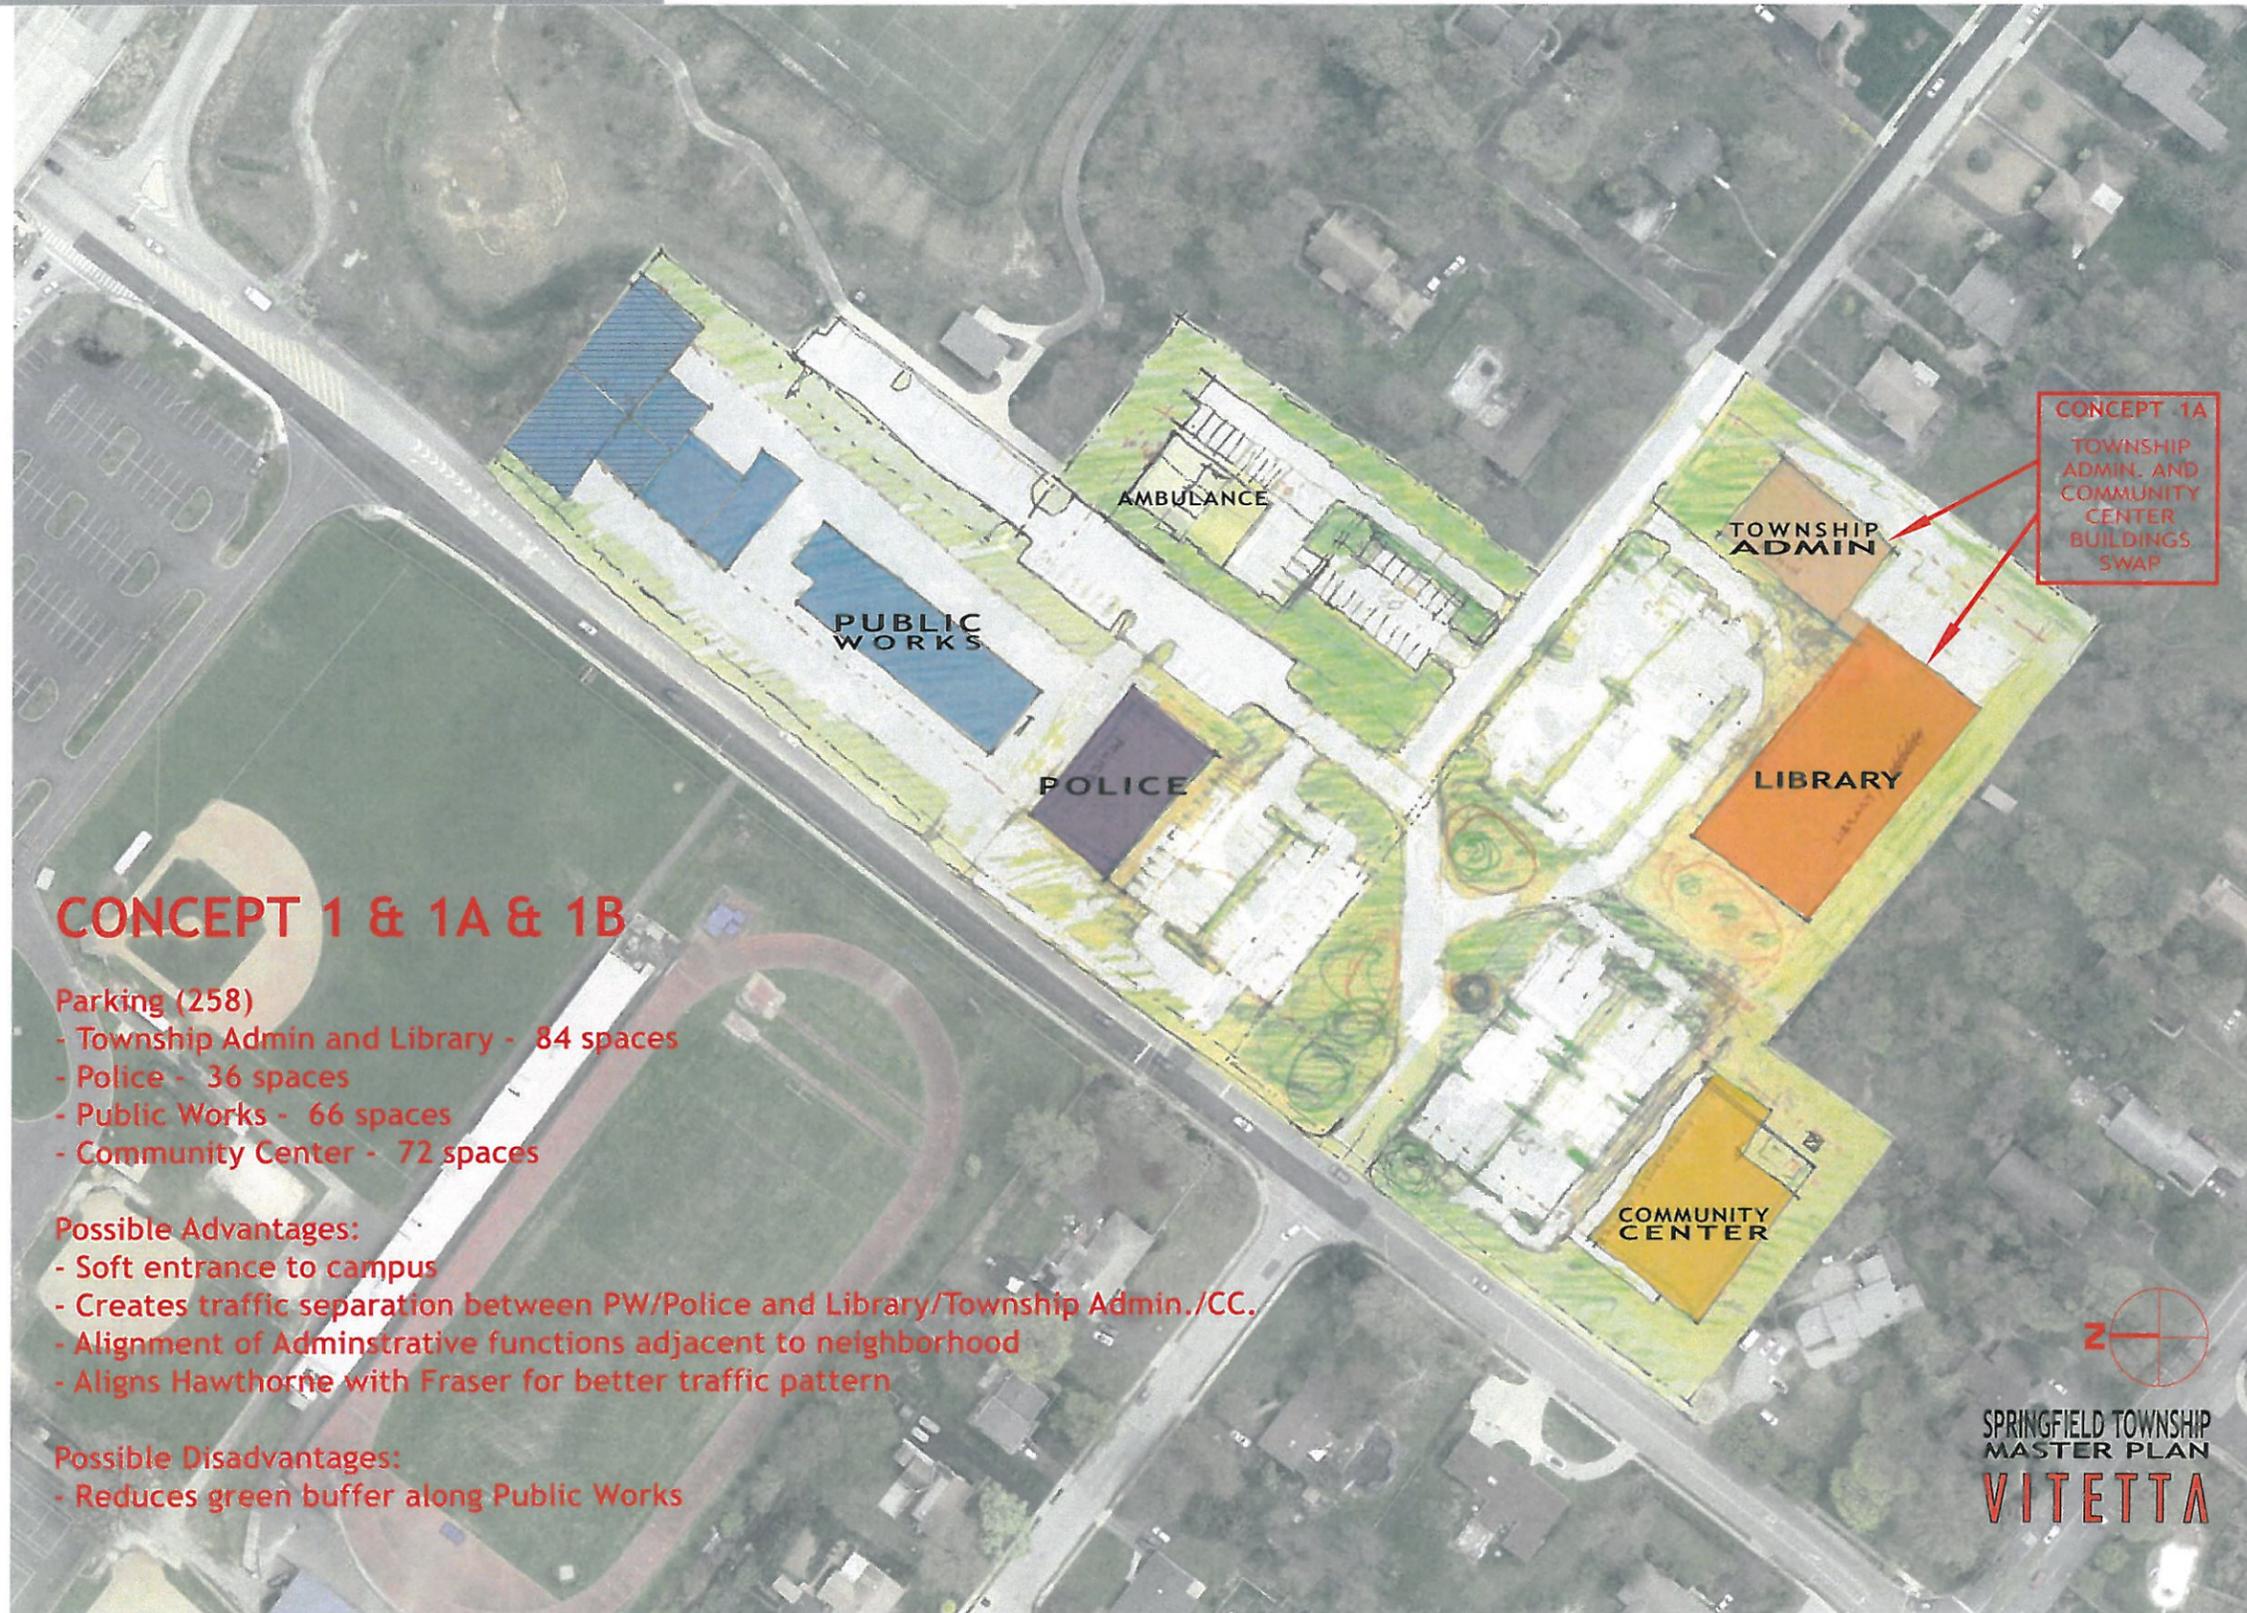
CONCEPT 1 & 1A & 1B

Parking (258)

- Reduces green buffer along Public Works

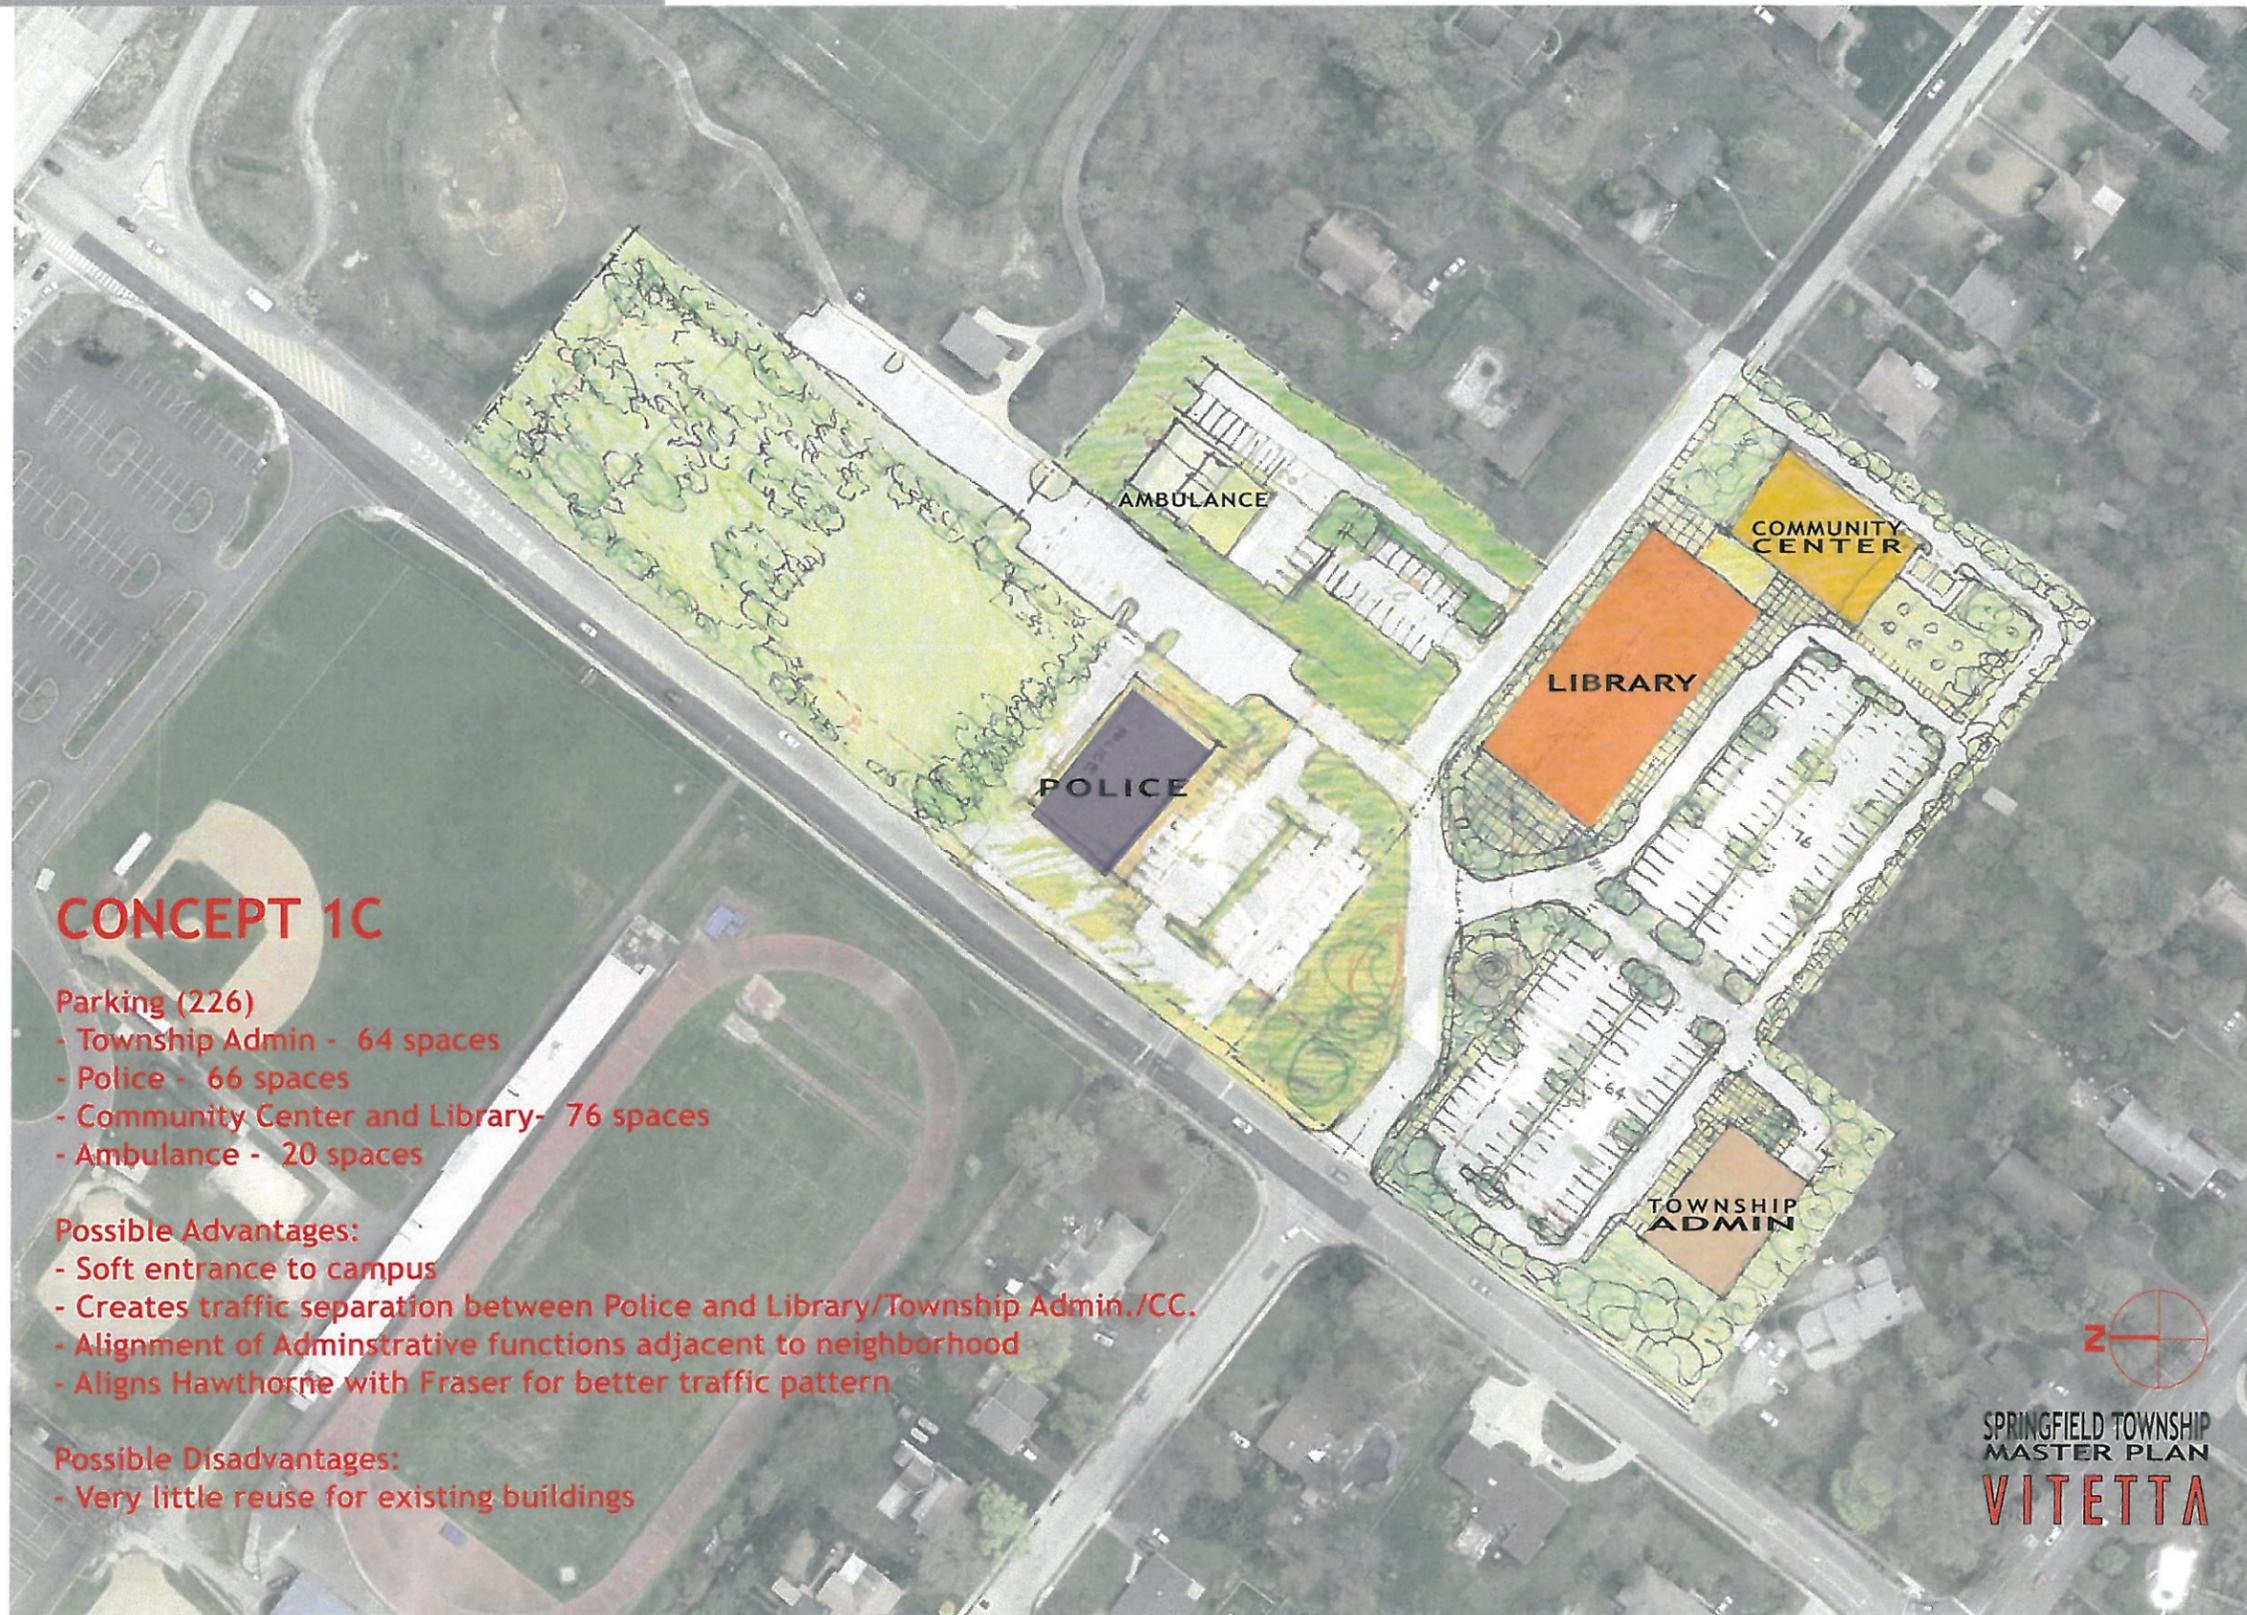
CONCEPT 1C

Parking (226)

Possible Disadvantages:

- Very little reuse for existing buildings

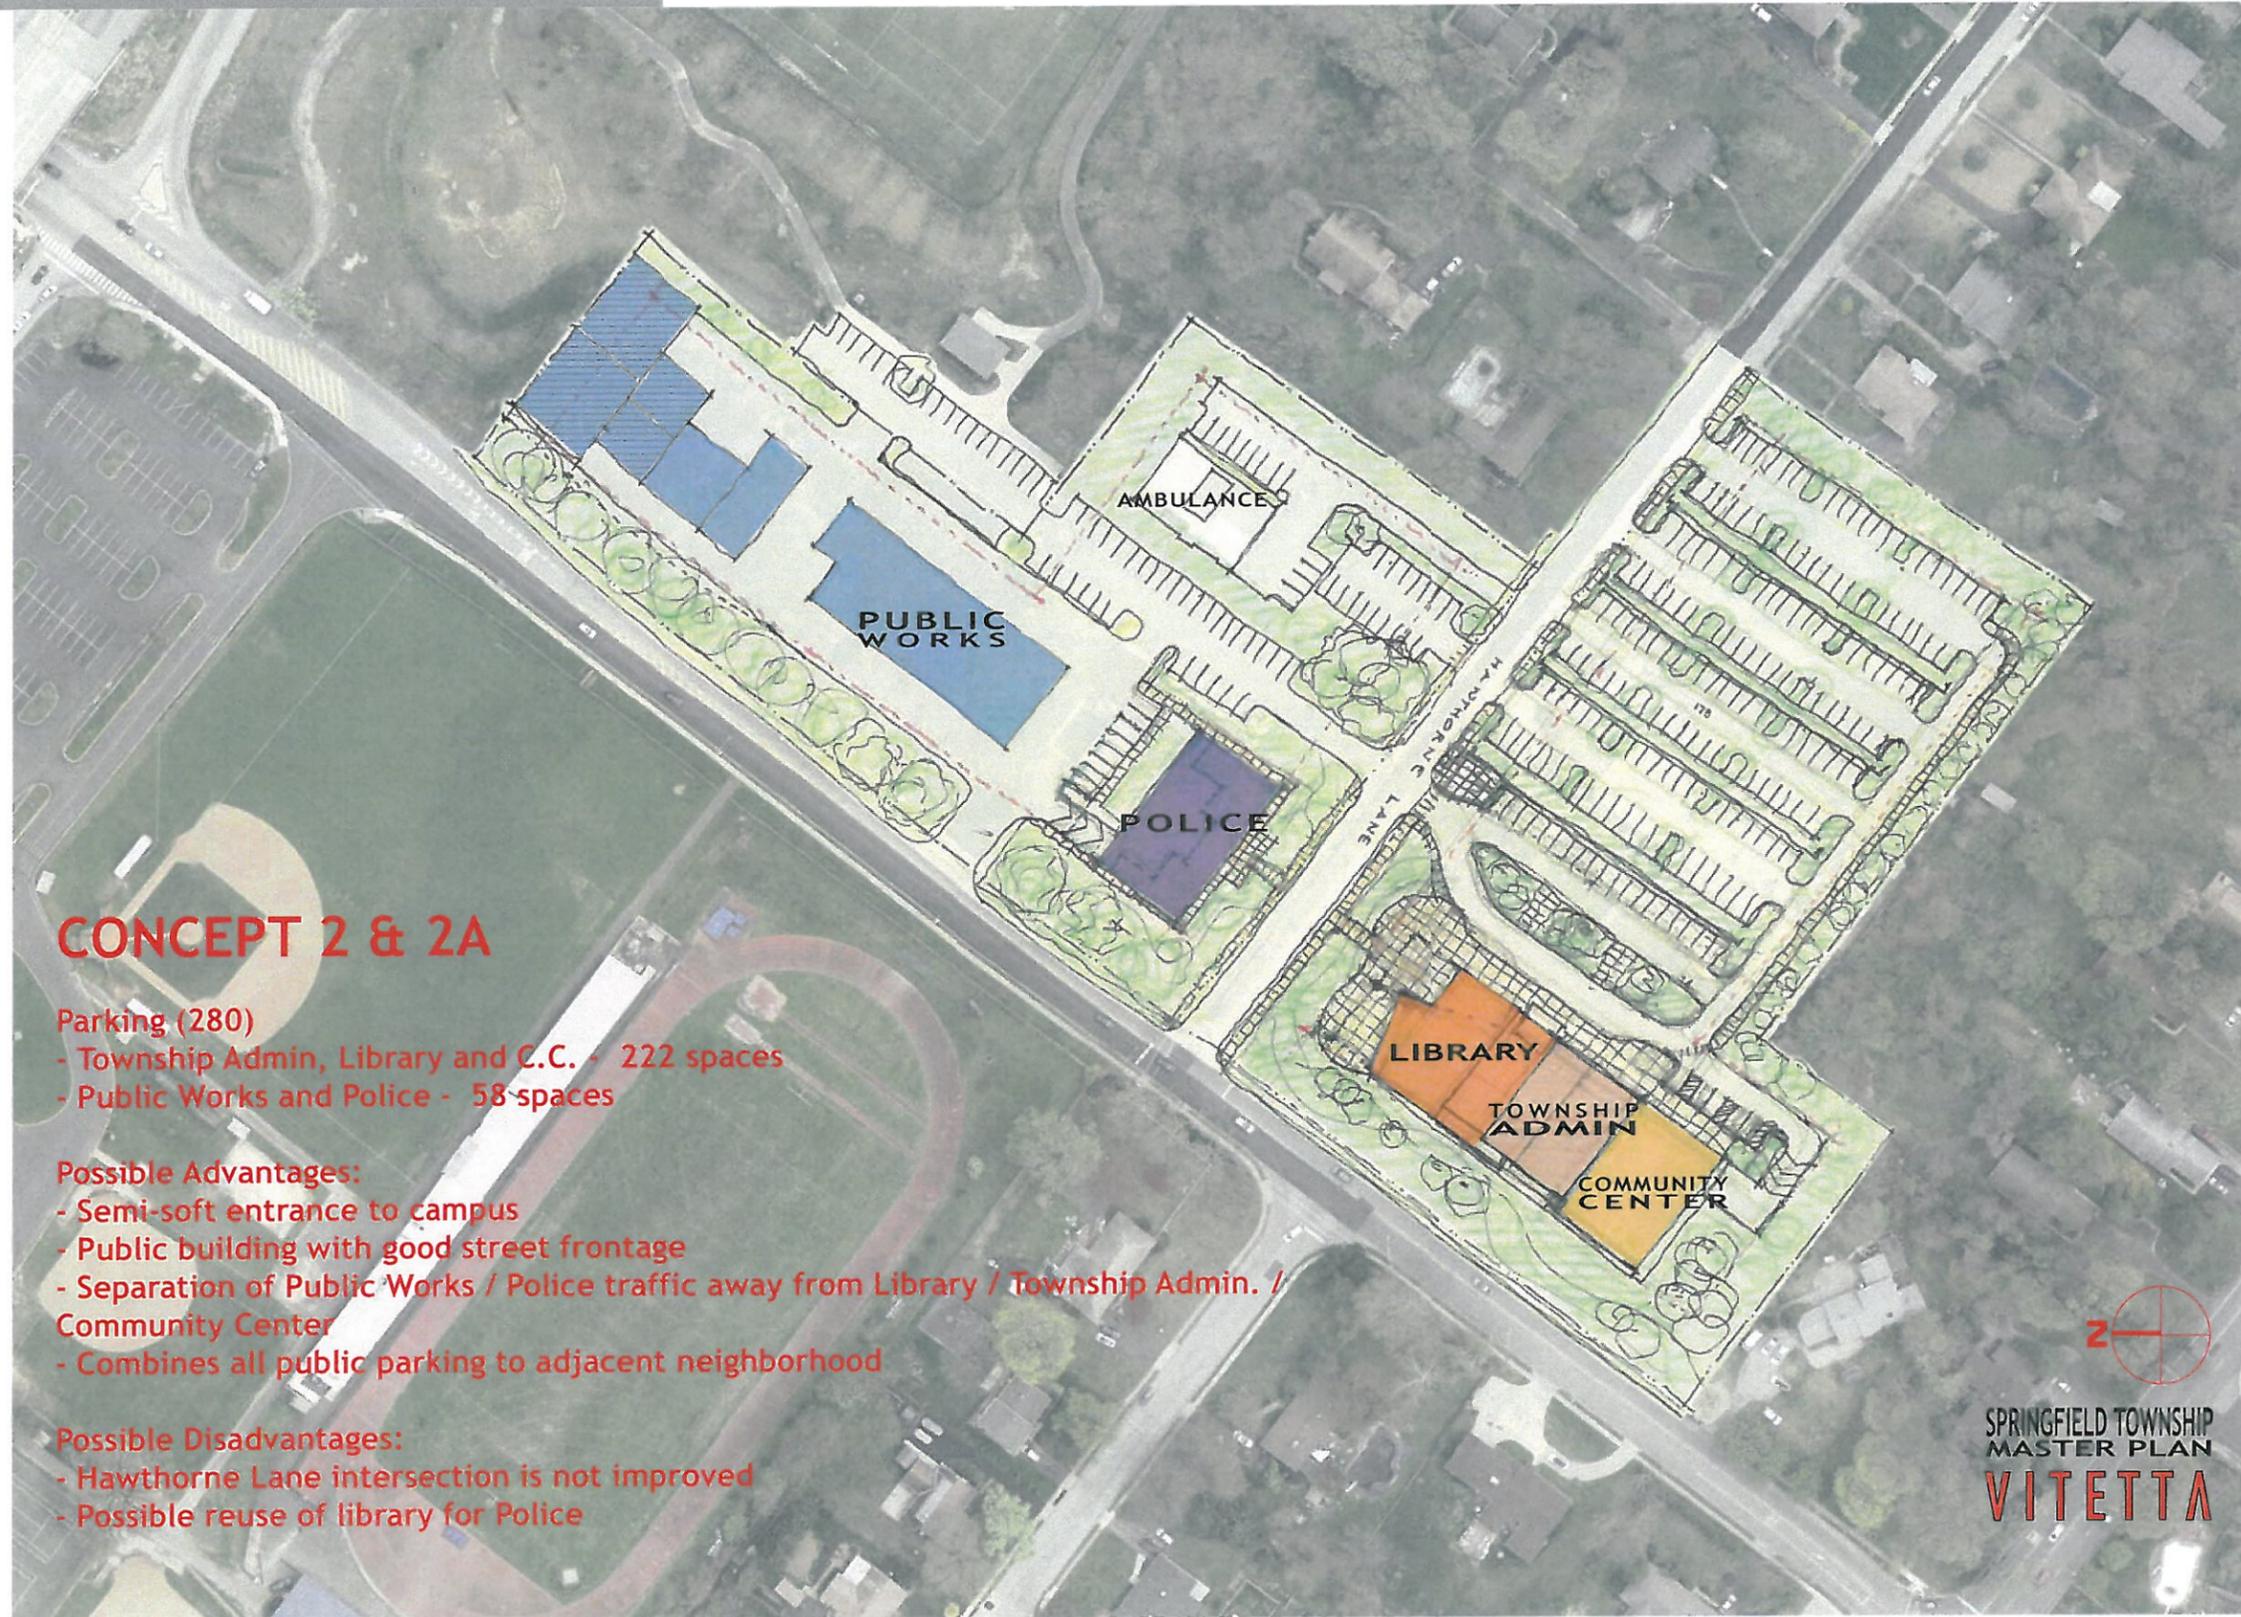
CONCEPT 2 & 2A

Parking (280)

Possible Disadvantages:

- Hawthorne Lane intersection is not improved
- Possible reuse of library for Police

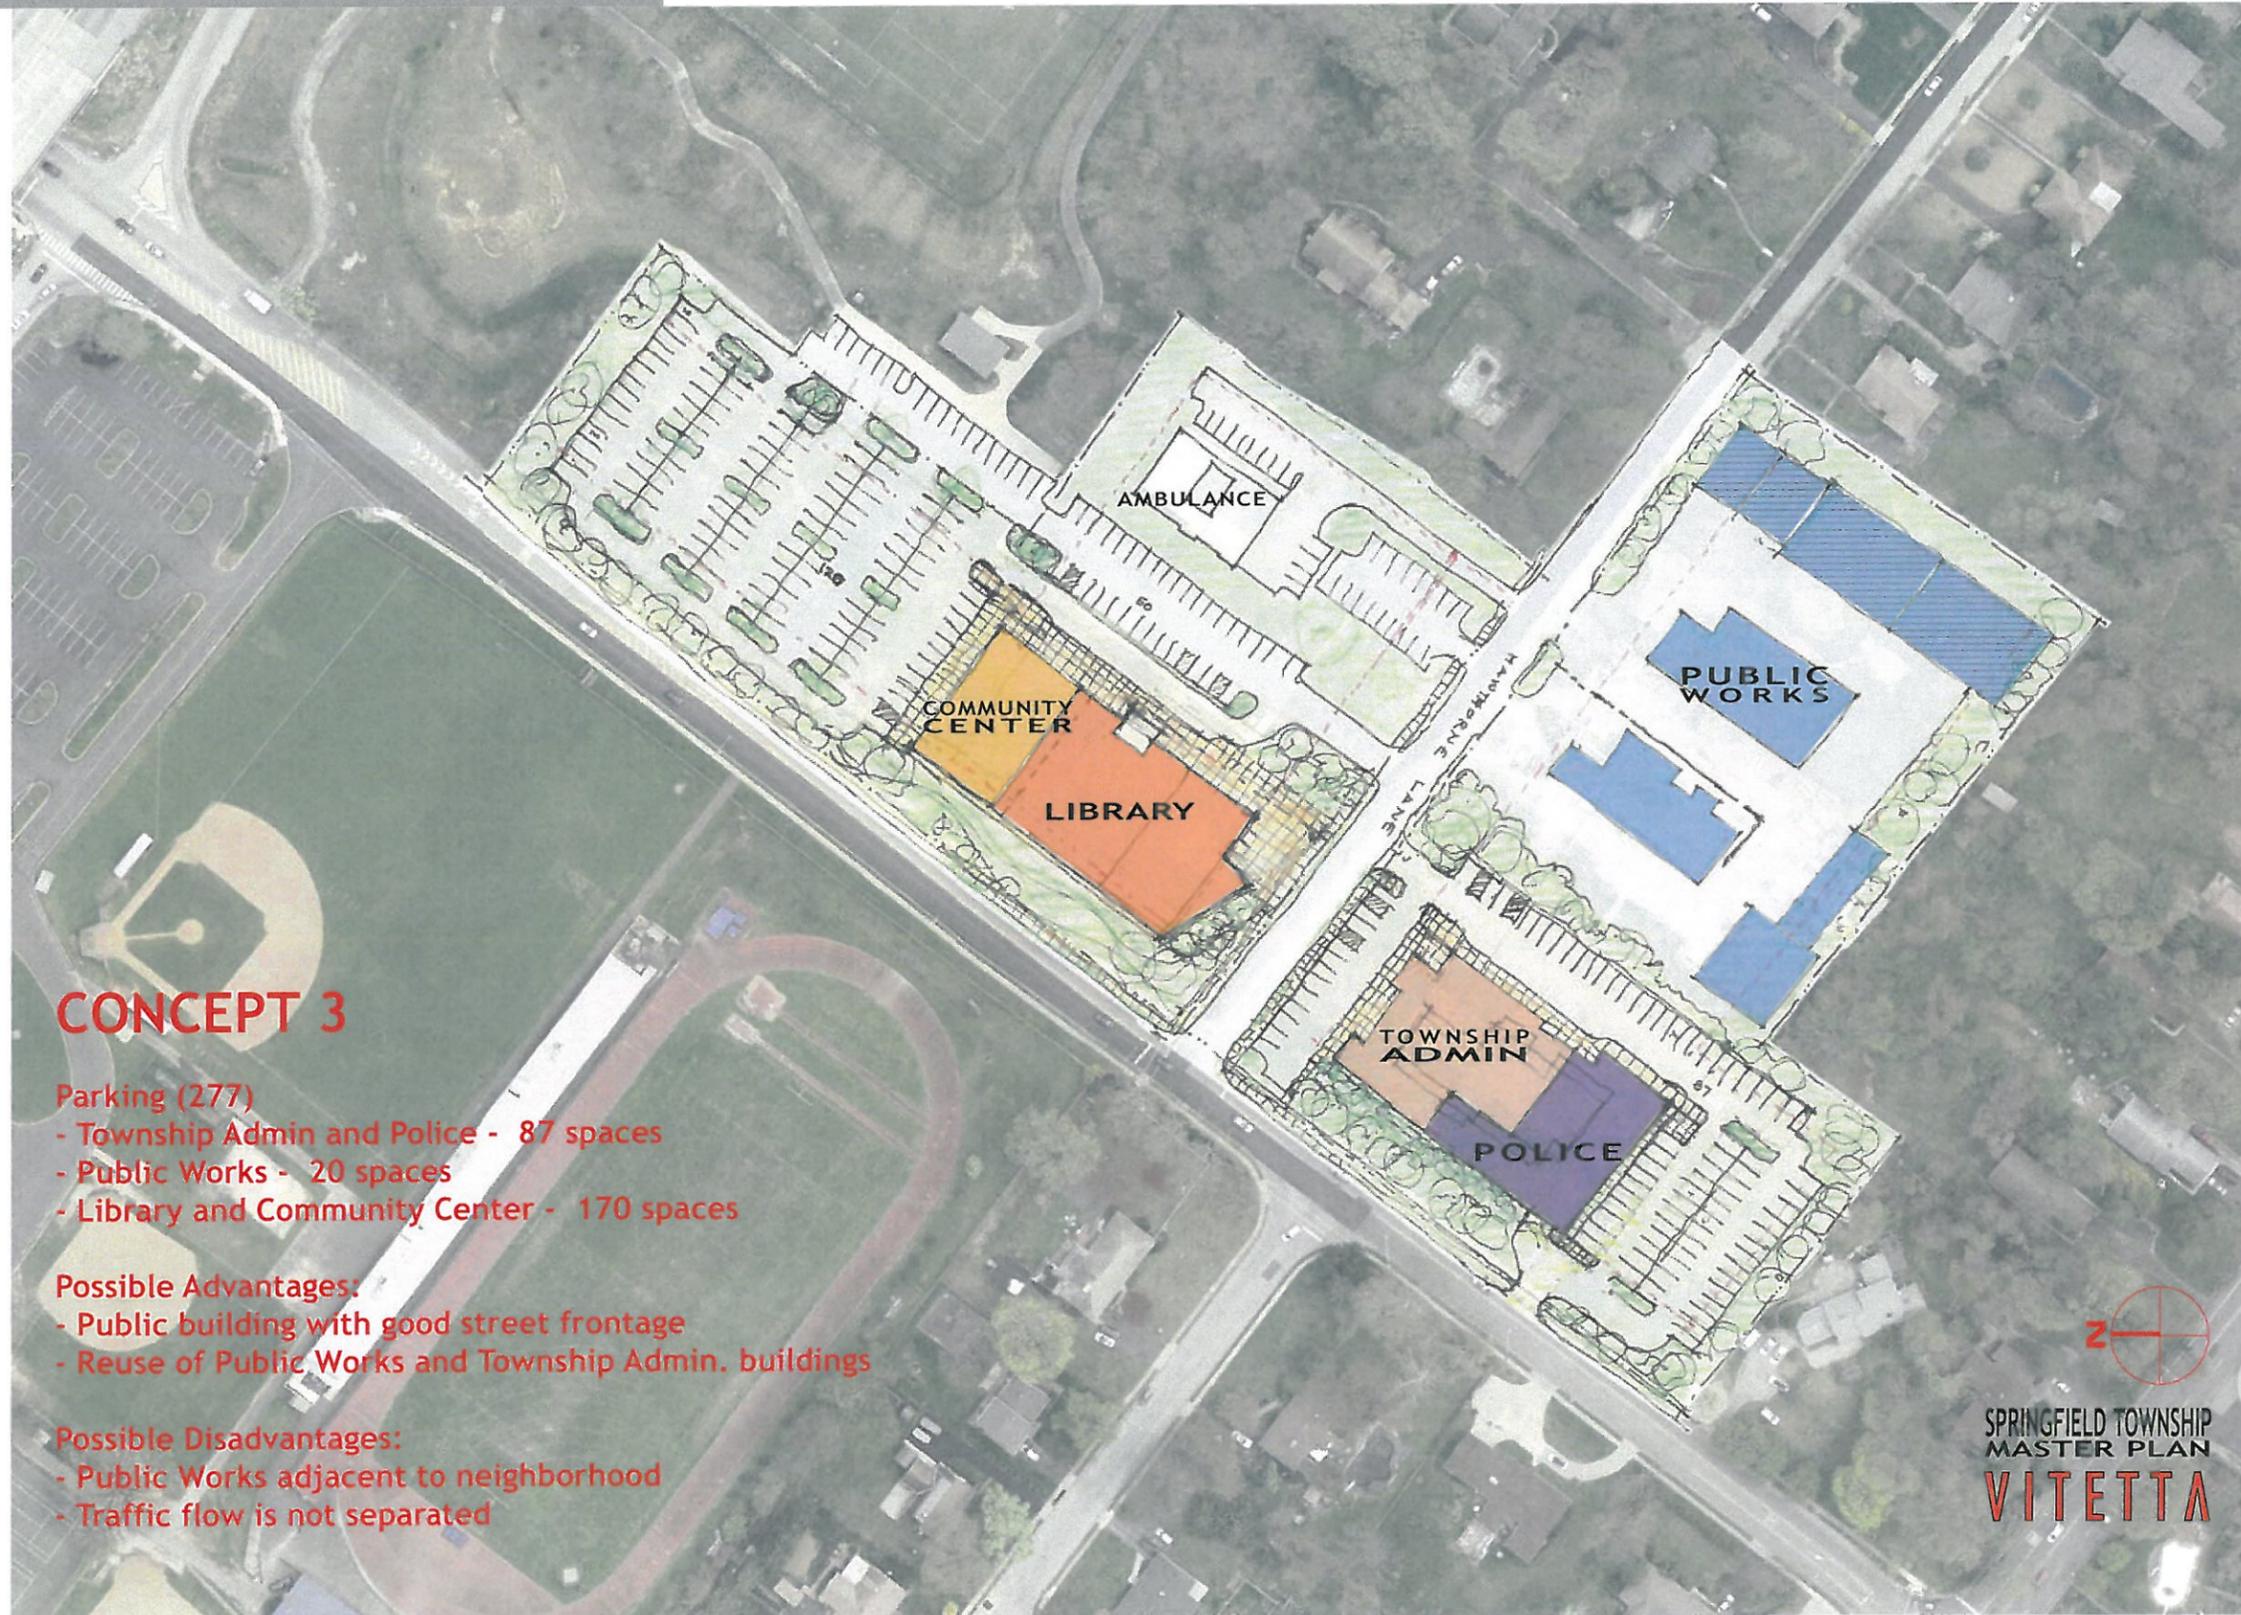
CONCEPT 3

- Parking (277)**
- Township Admin and Police - 87 spaces
 - Public Works - 20 spaces
 - Library and Community Center - 170 spaces

- Possible Advantages:**
- Public building with good street frontage
 - Reuse of Public Works and Township Admin. buildings

- Possible Disadvantages:**
- Public Works adjacent to neighborhood
 - Traffic flow is not separated
