RE: SPRINGFIELD TOWNSHIP MUNICIPAL CAMPUS MASTER PLAN

VITETTA Architects and Engineers is proud to forward our summary report and recommendations for the Springfield Township Municipal Campus Master Plan. This report summarizes our work with the Township and the Advisory Committee to review the previously prepared plan and help developed a consensus plan for how best to meet the now and future needs of the Township government and its ability to provide services to the Township.

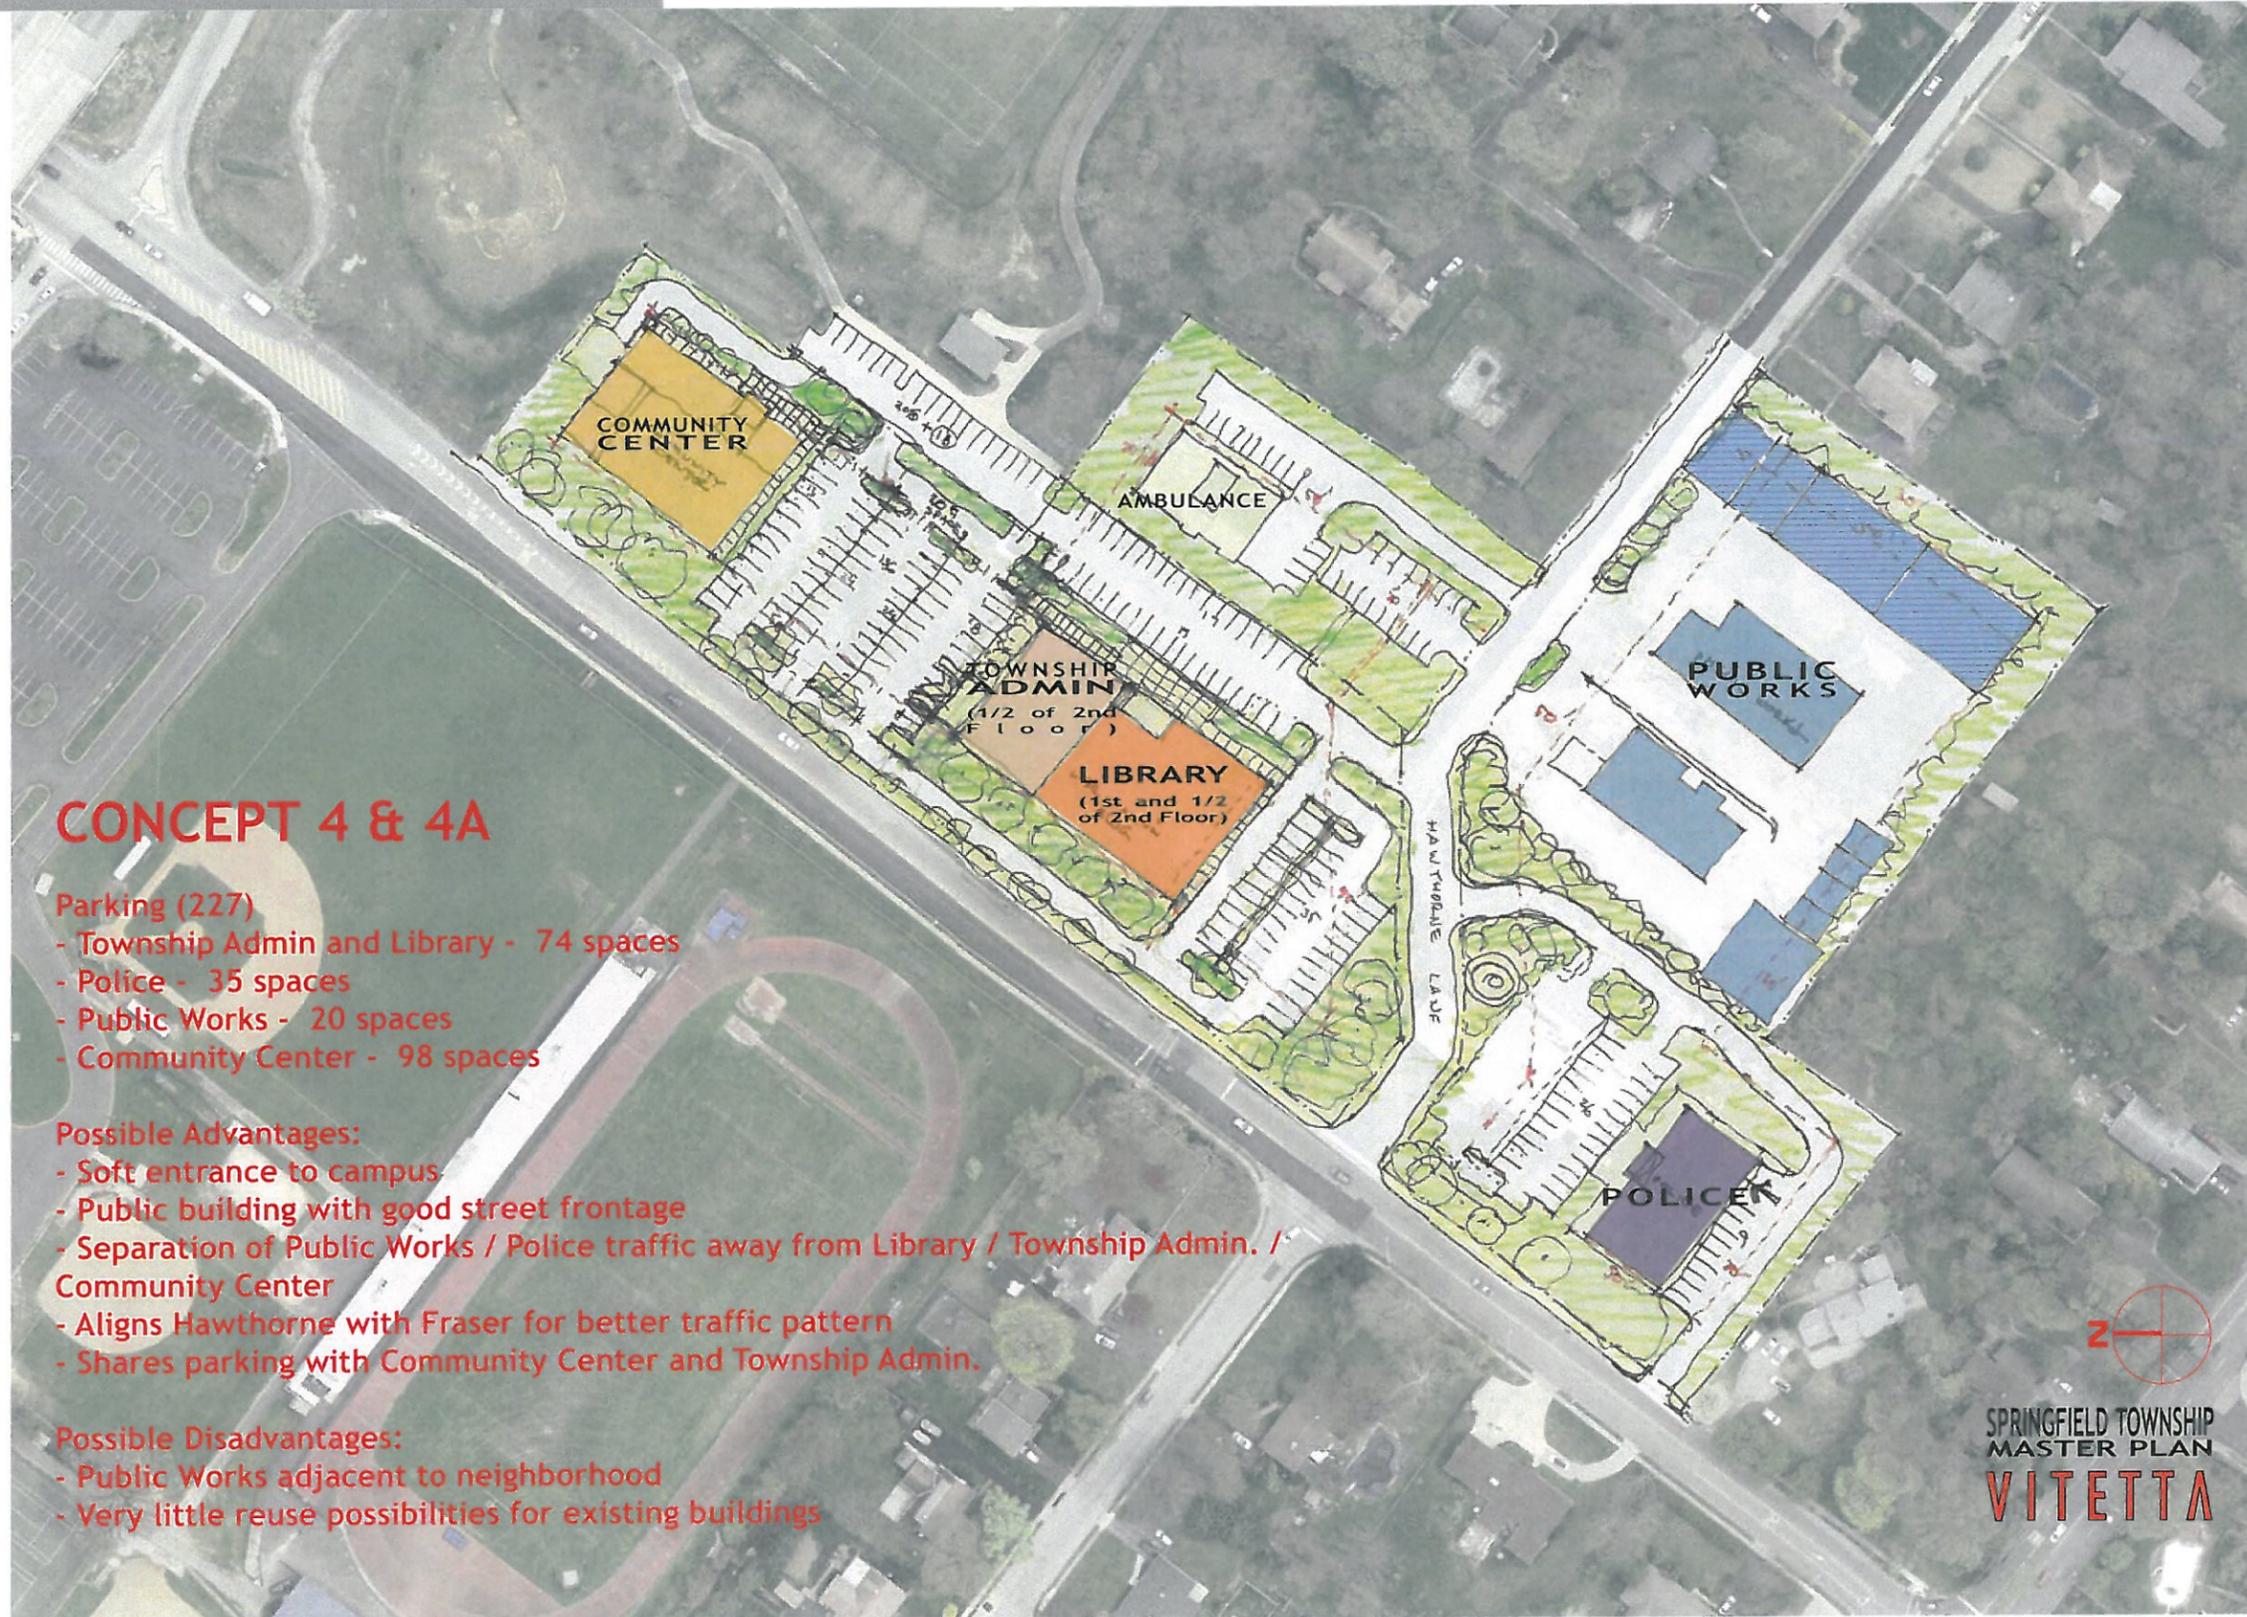
CONCEPT 4 & 4A

Parking (227)

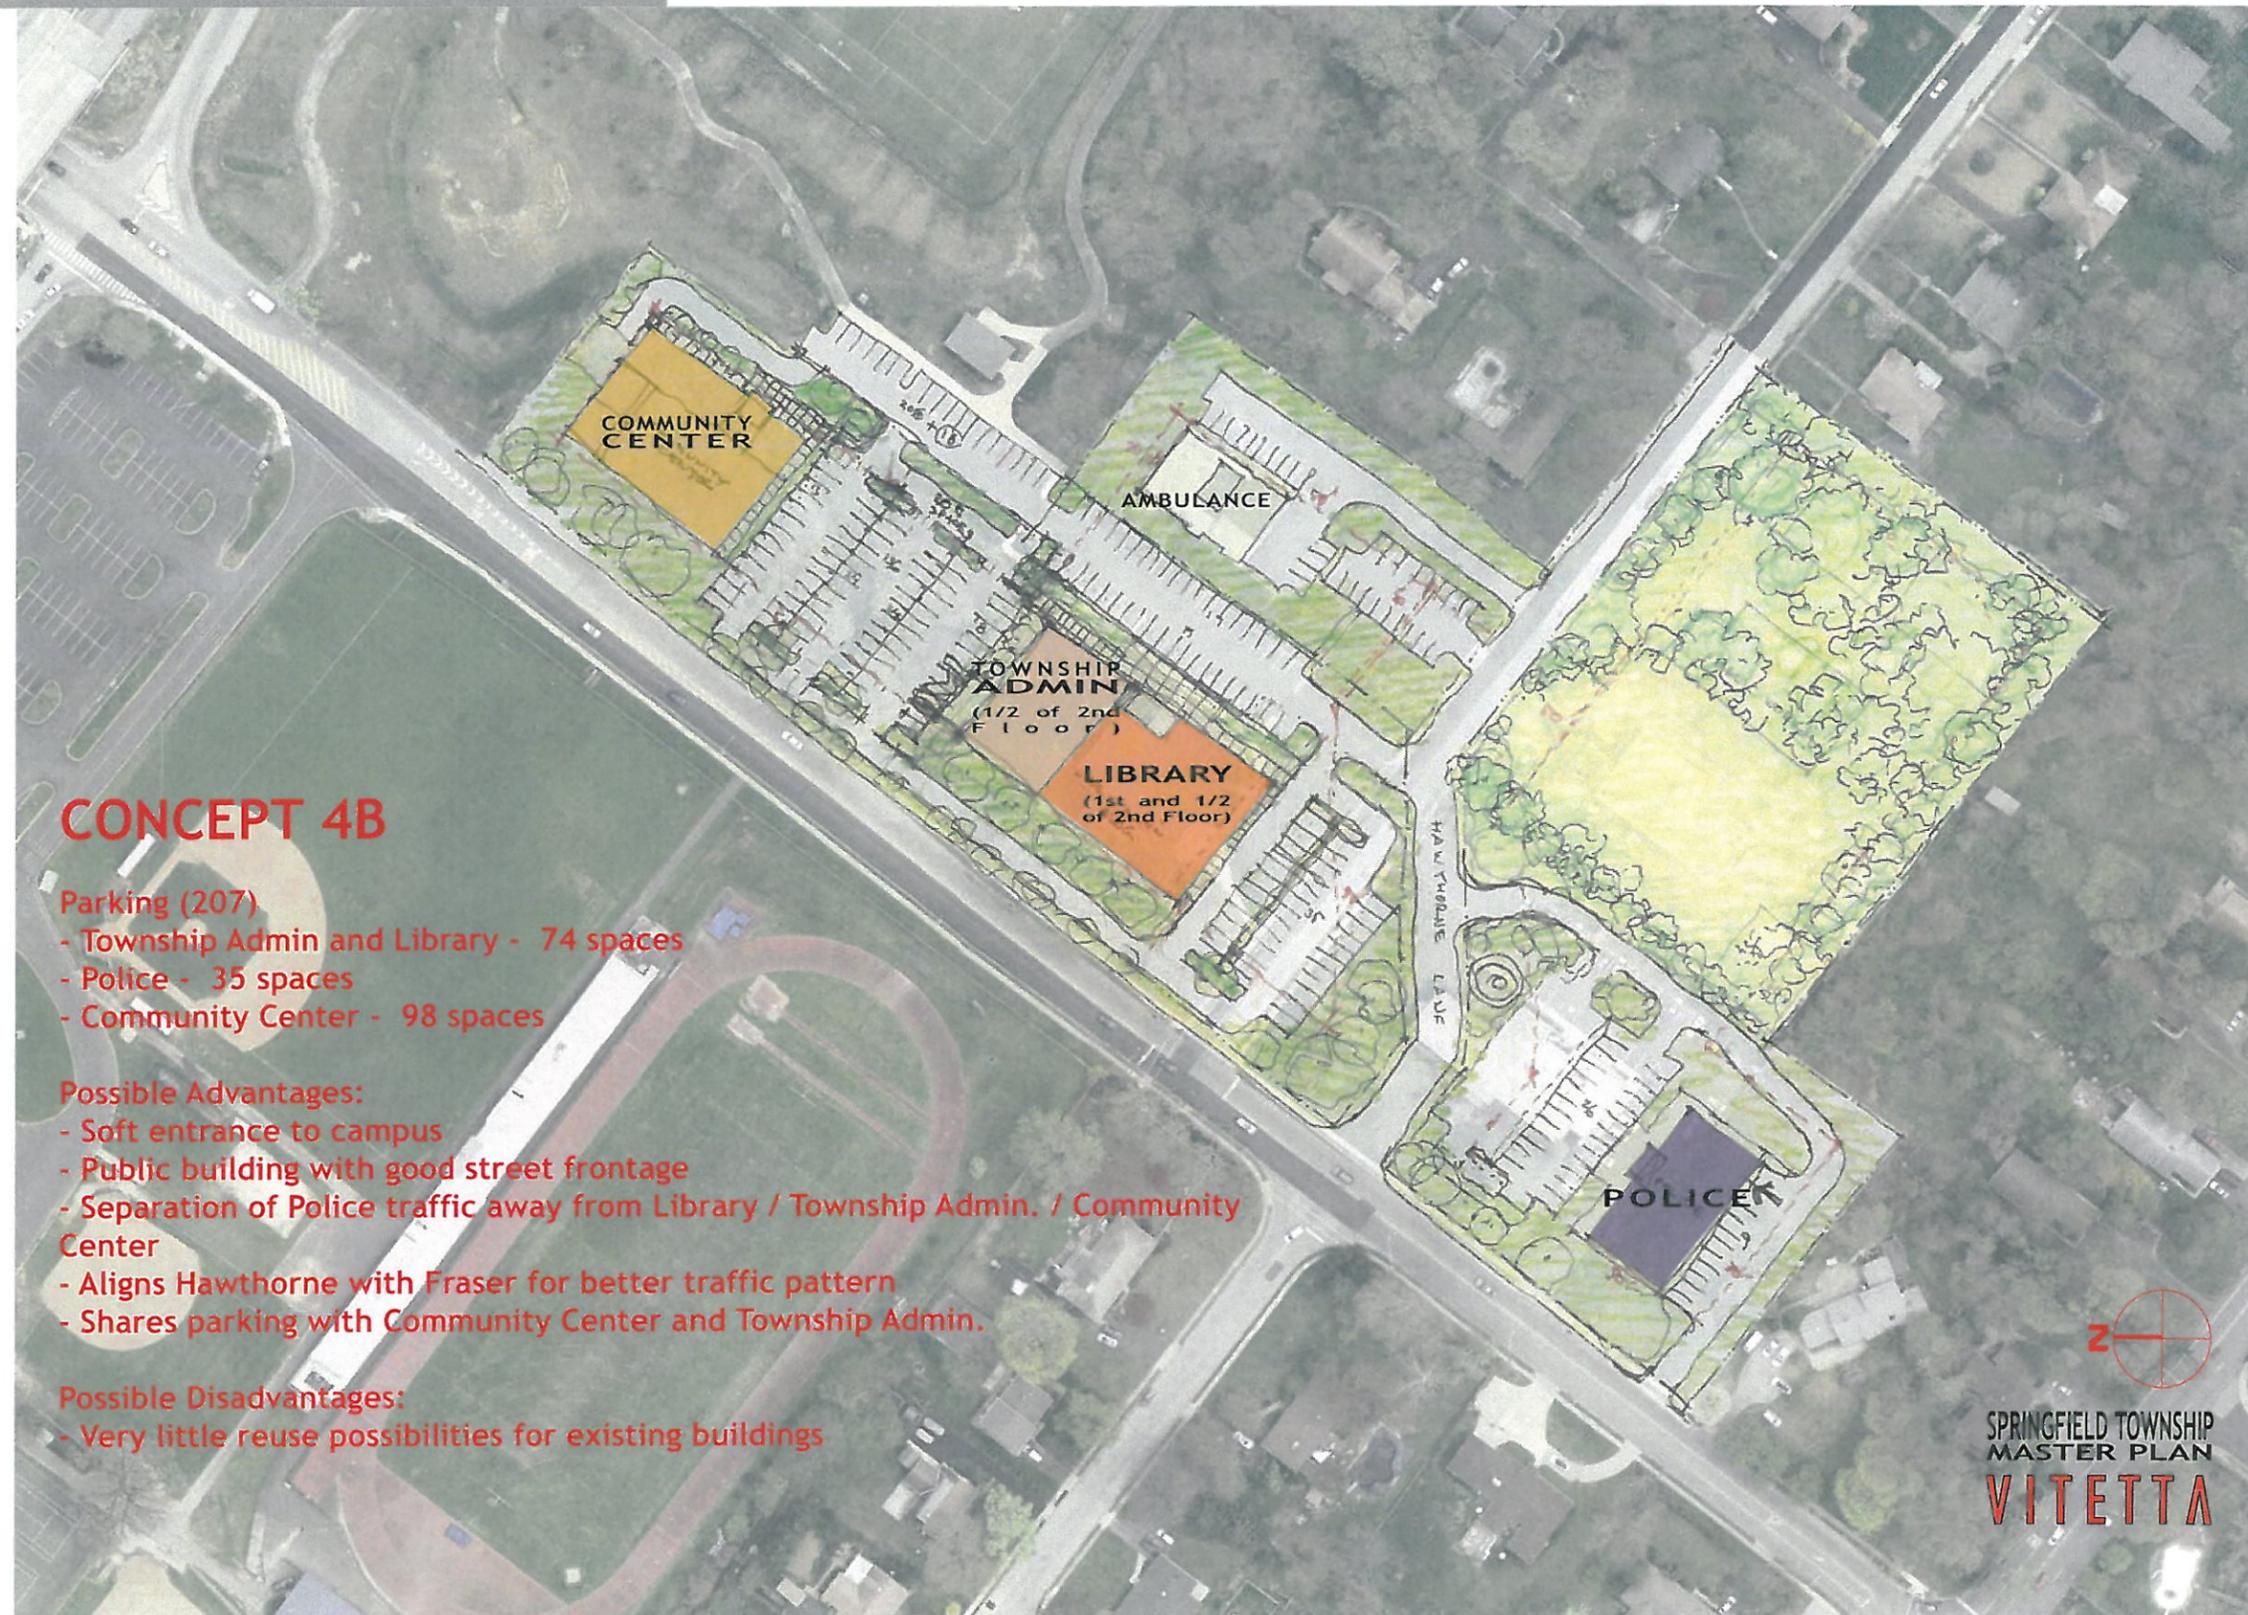
CONCEPT 4B

Parking (207)

This concept removes public works to another undetermined site. It, separates the police from the other uses on site similar to Concept 4 & 4A. It offers a public face to Paper Mill Road and maximizes the separation between the Campus and the neighbors to the south and east.

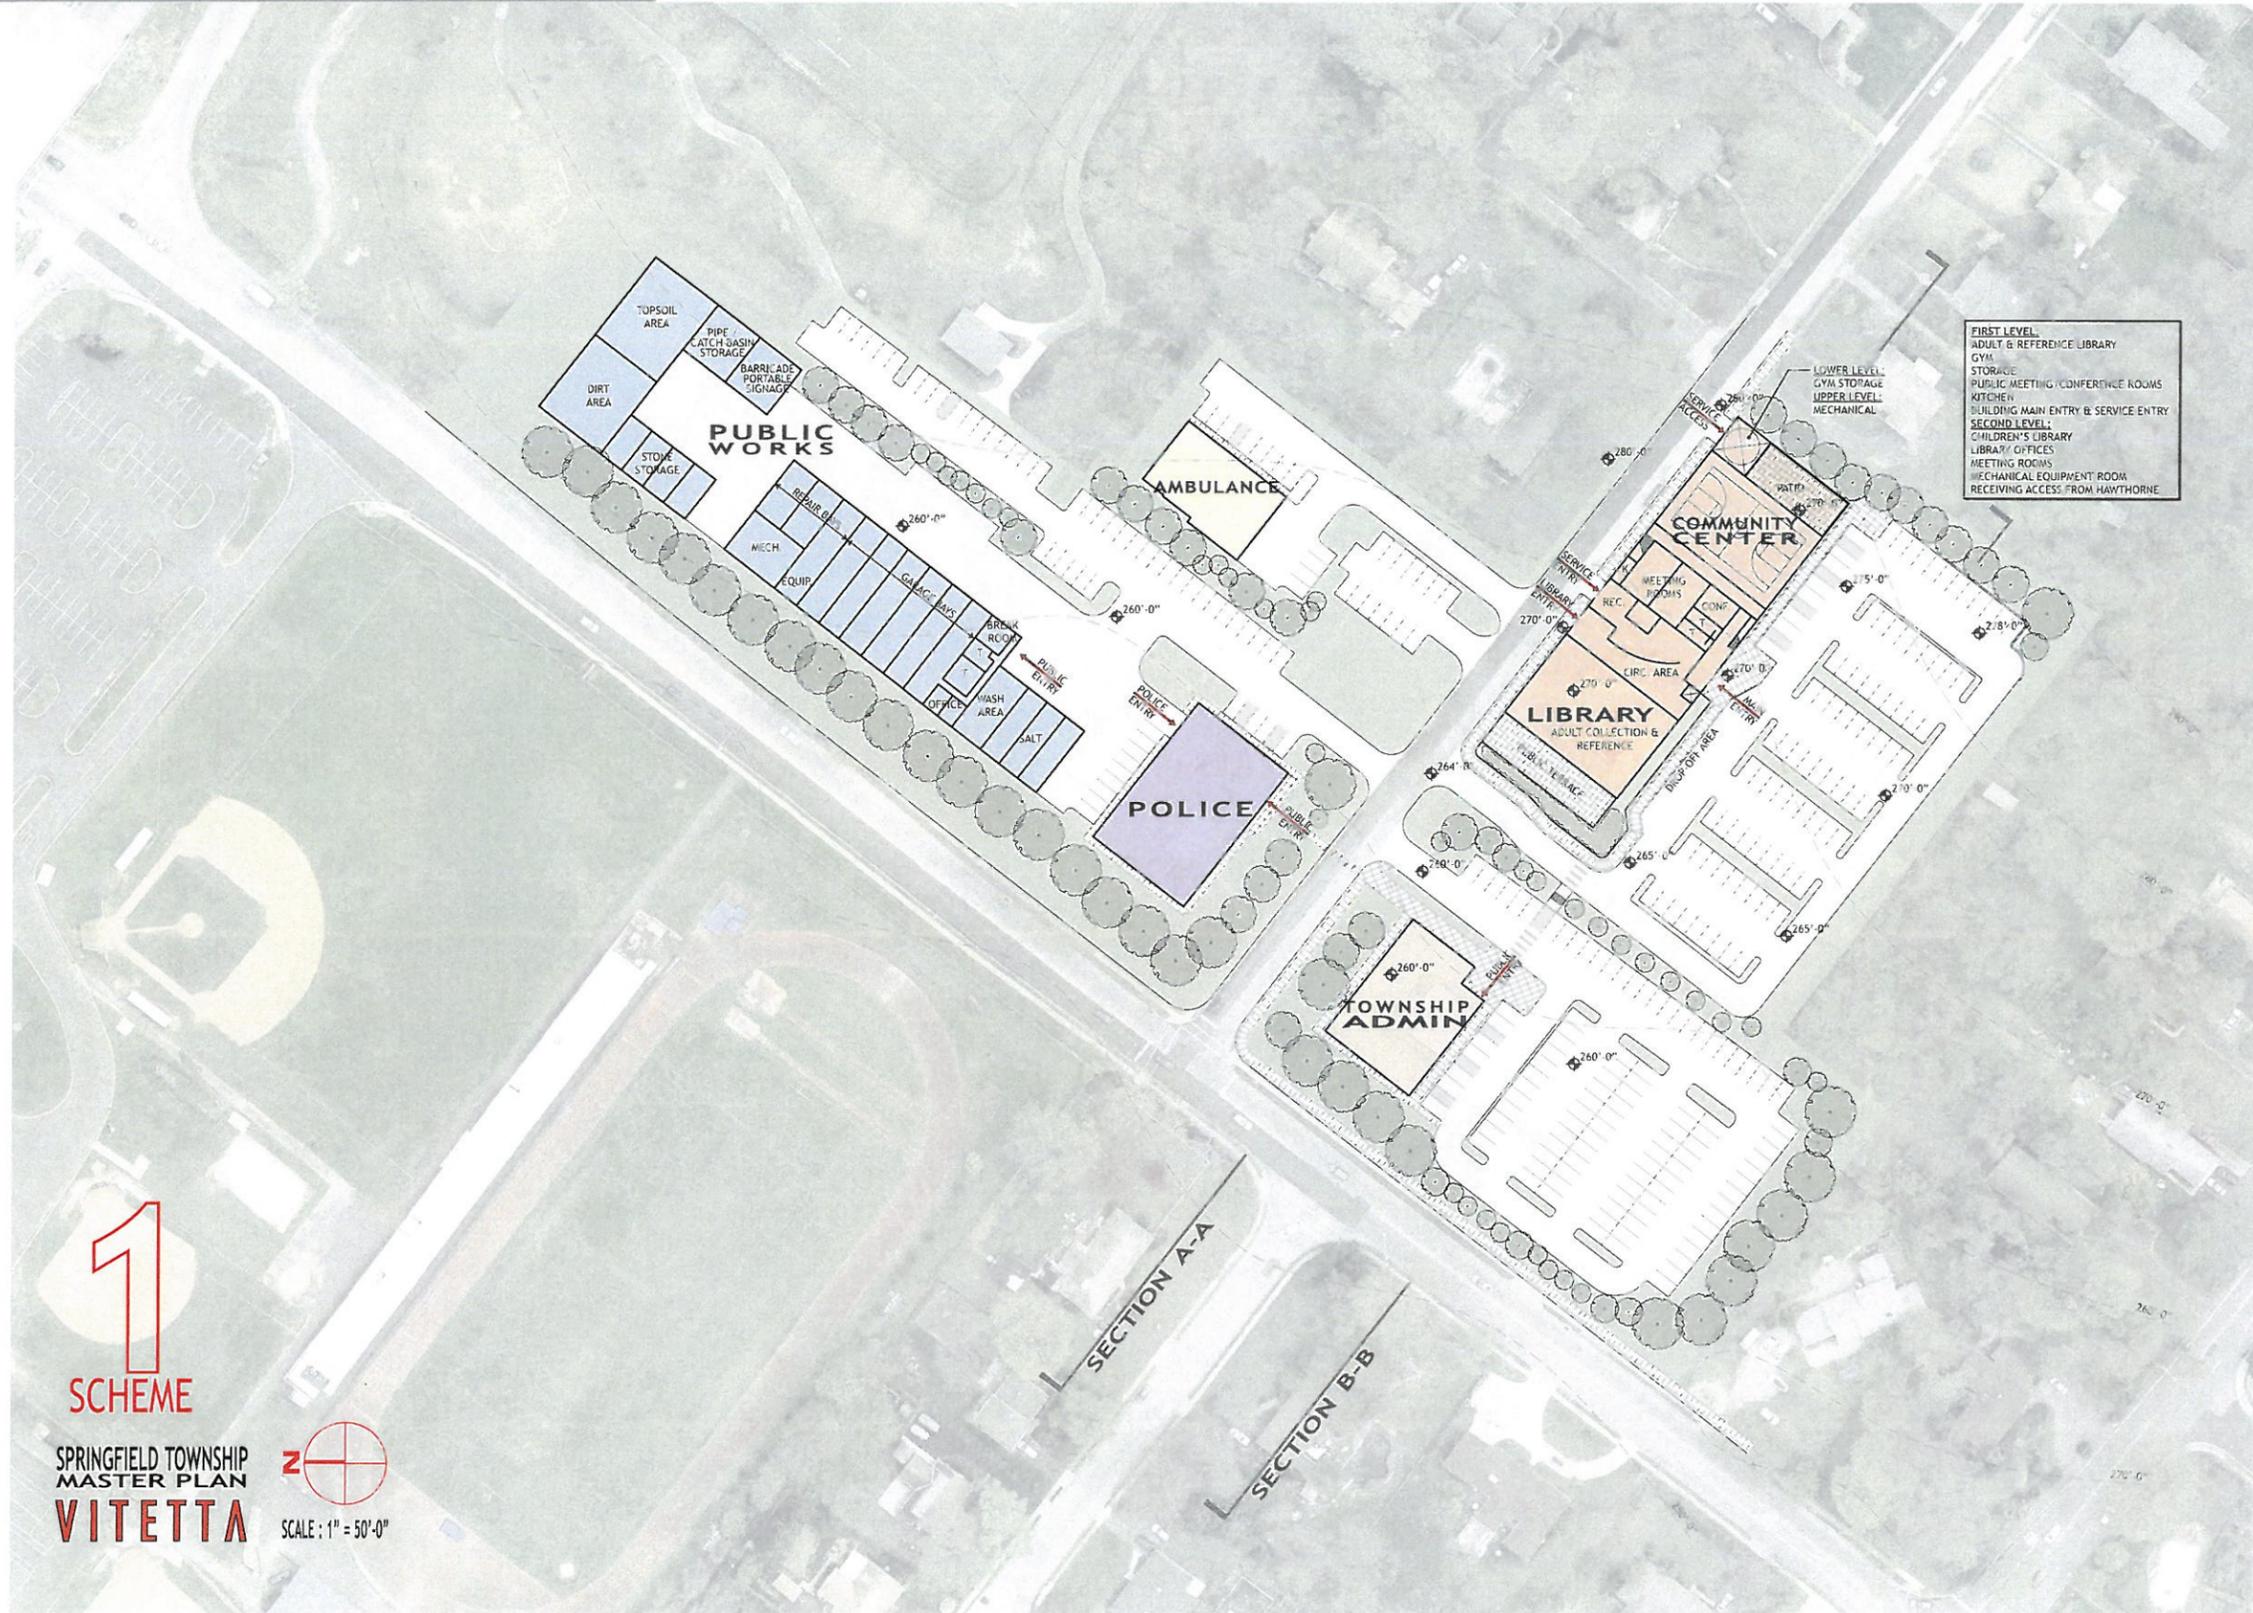
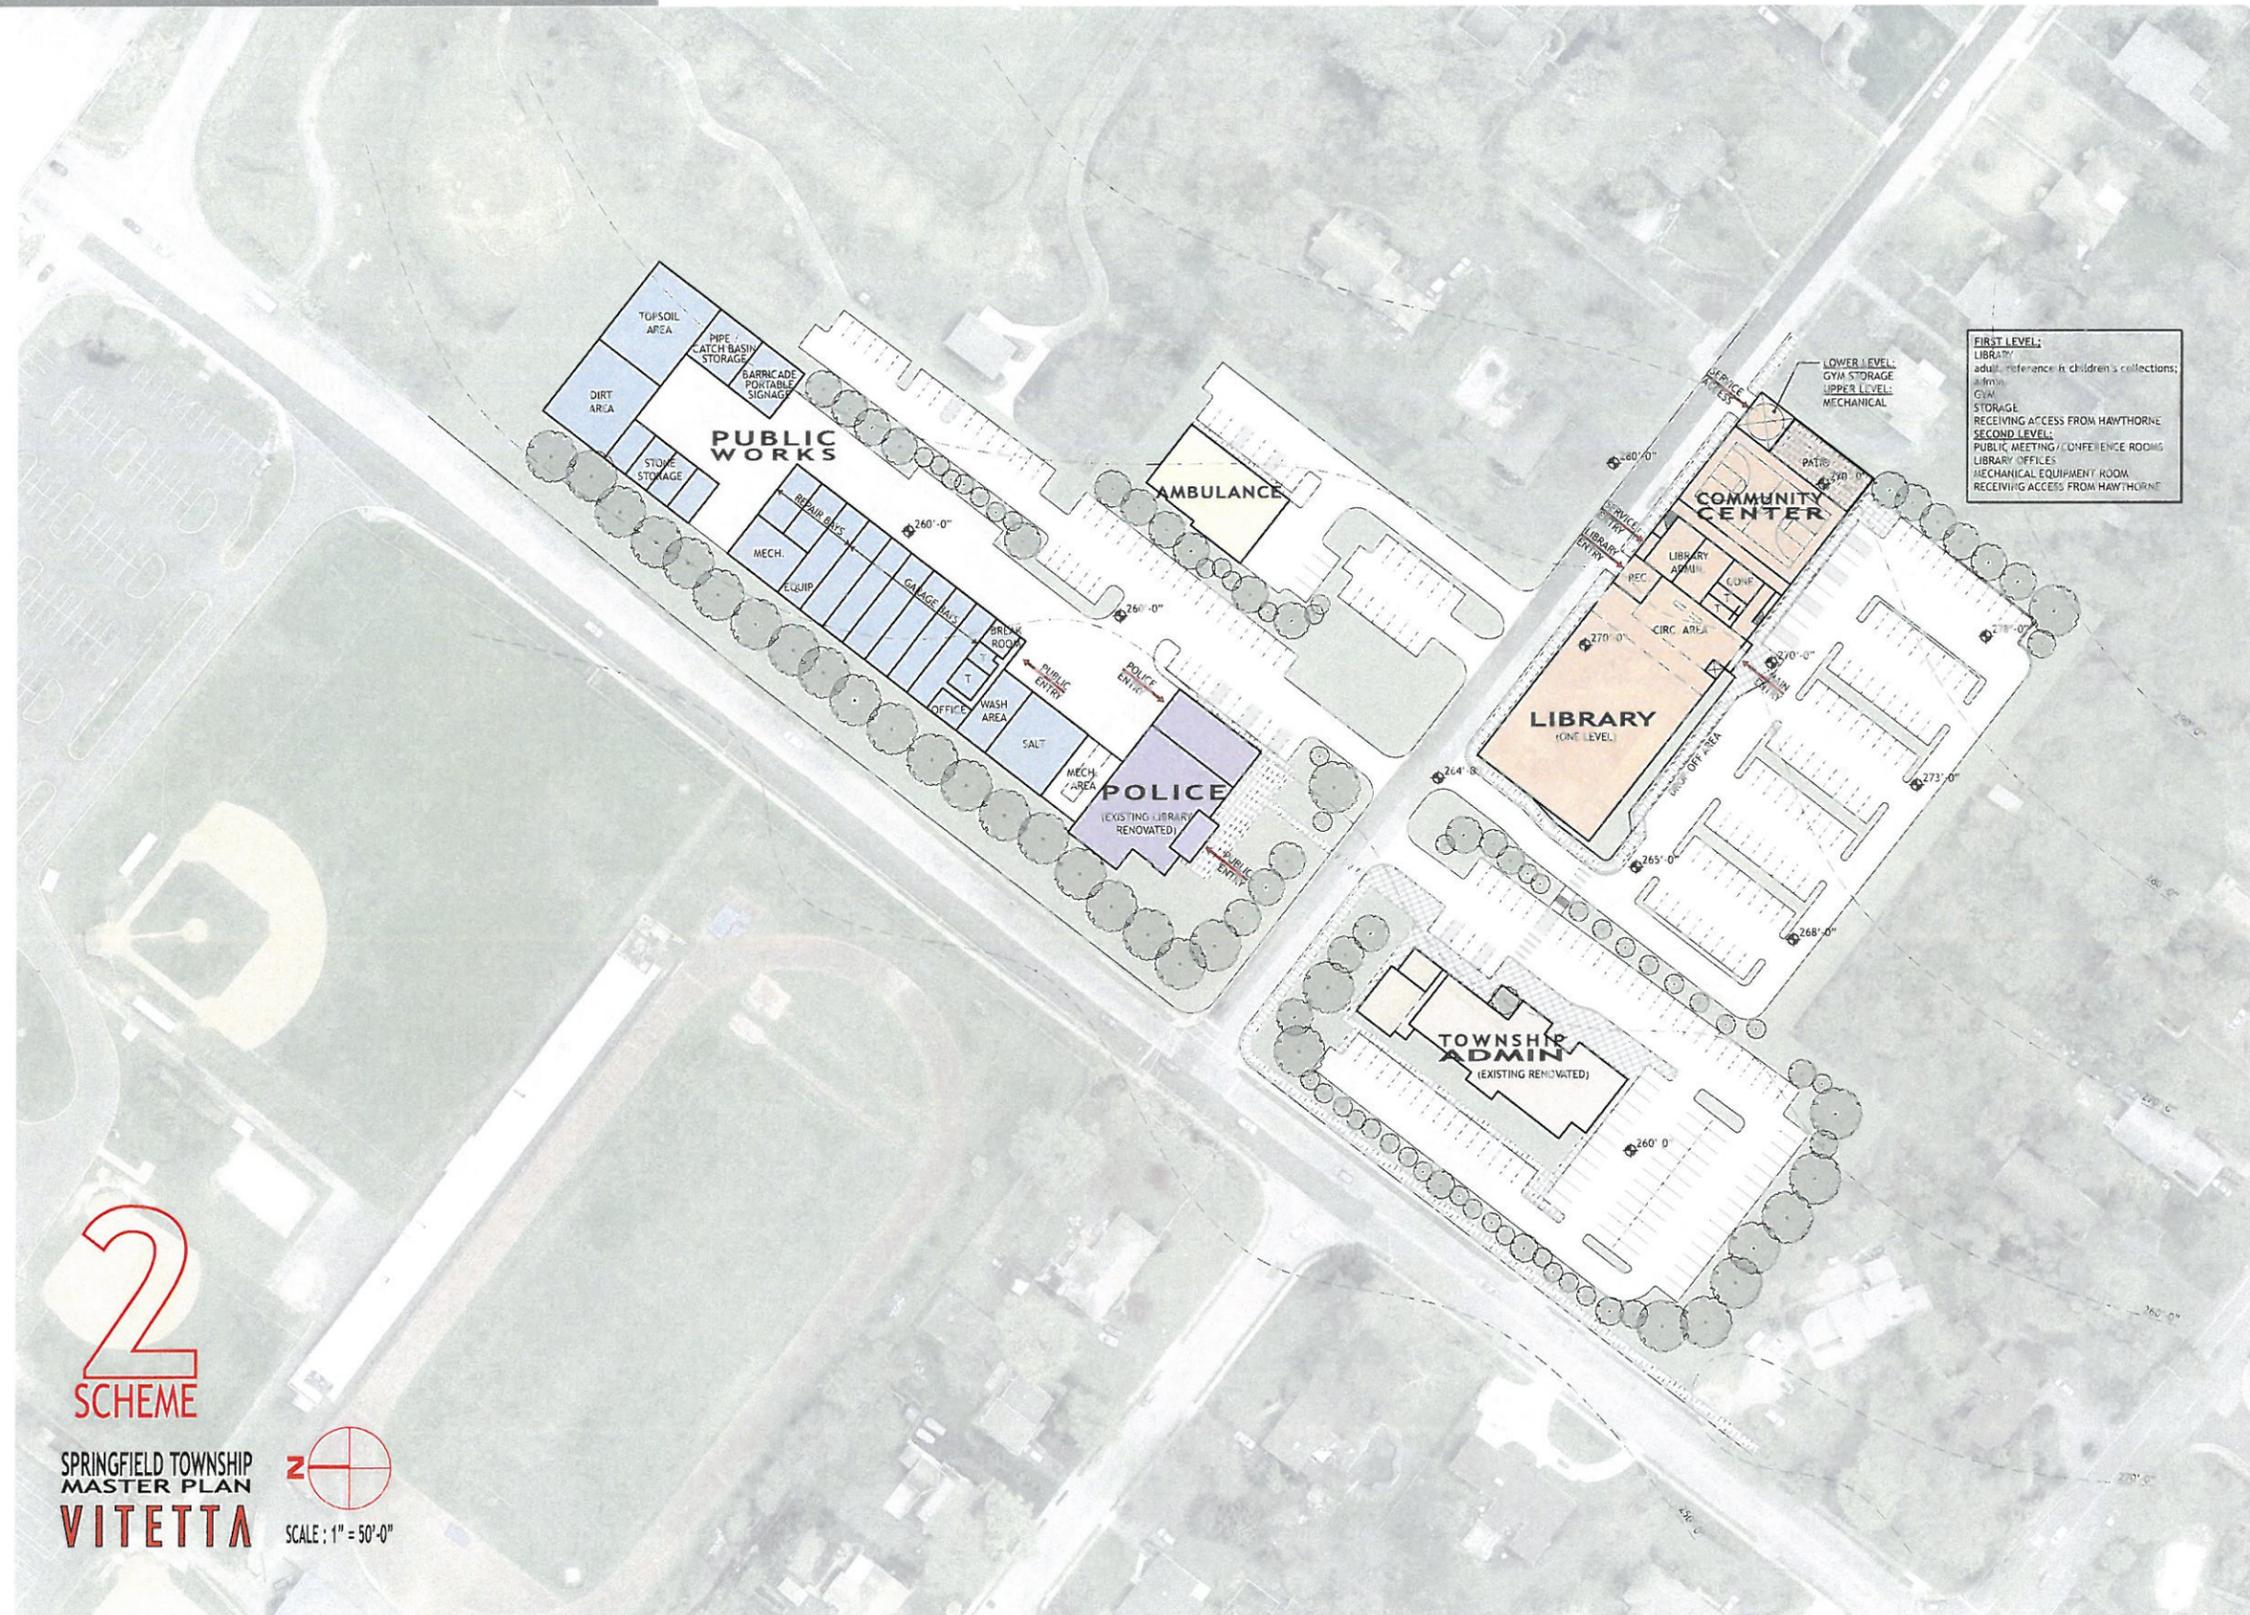
PARTIAL SITE PLAN & SECTIONS
SC 1:60 = 1" = 8'

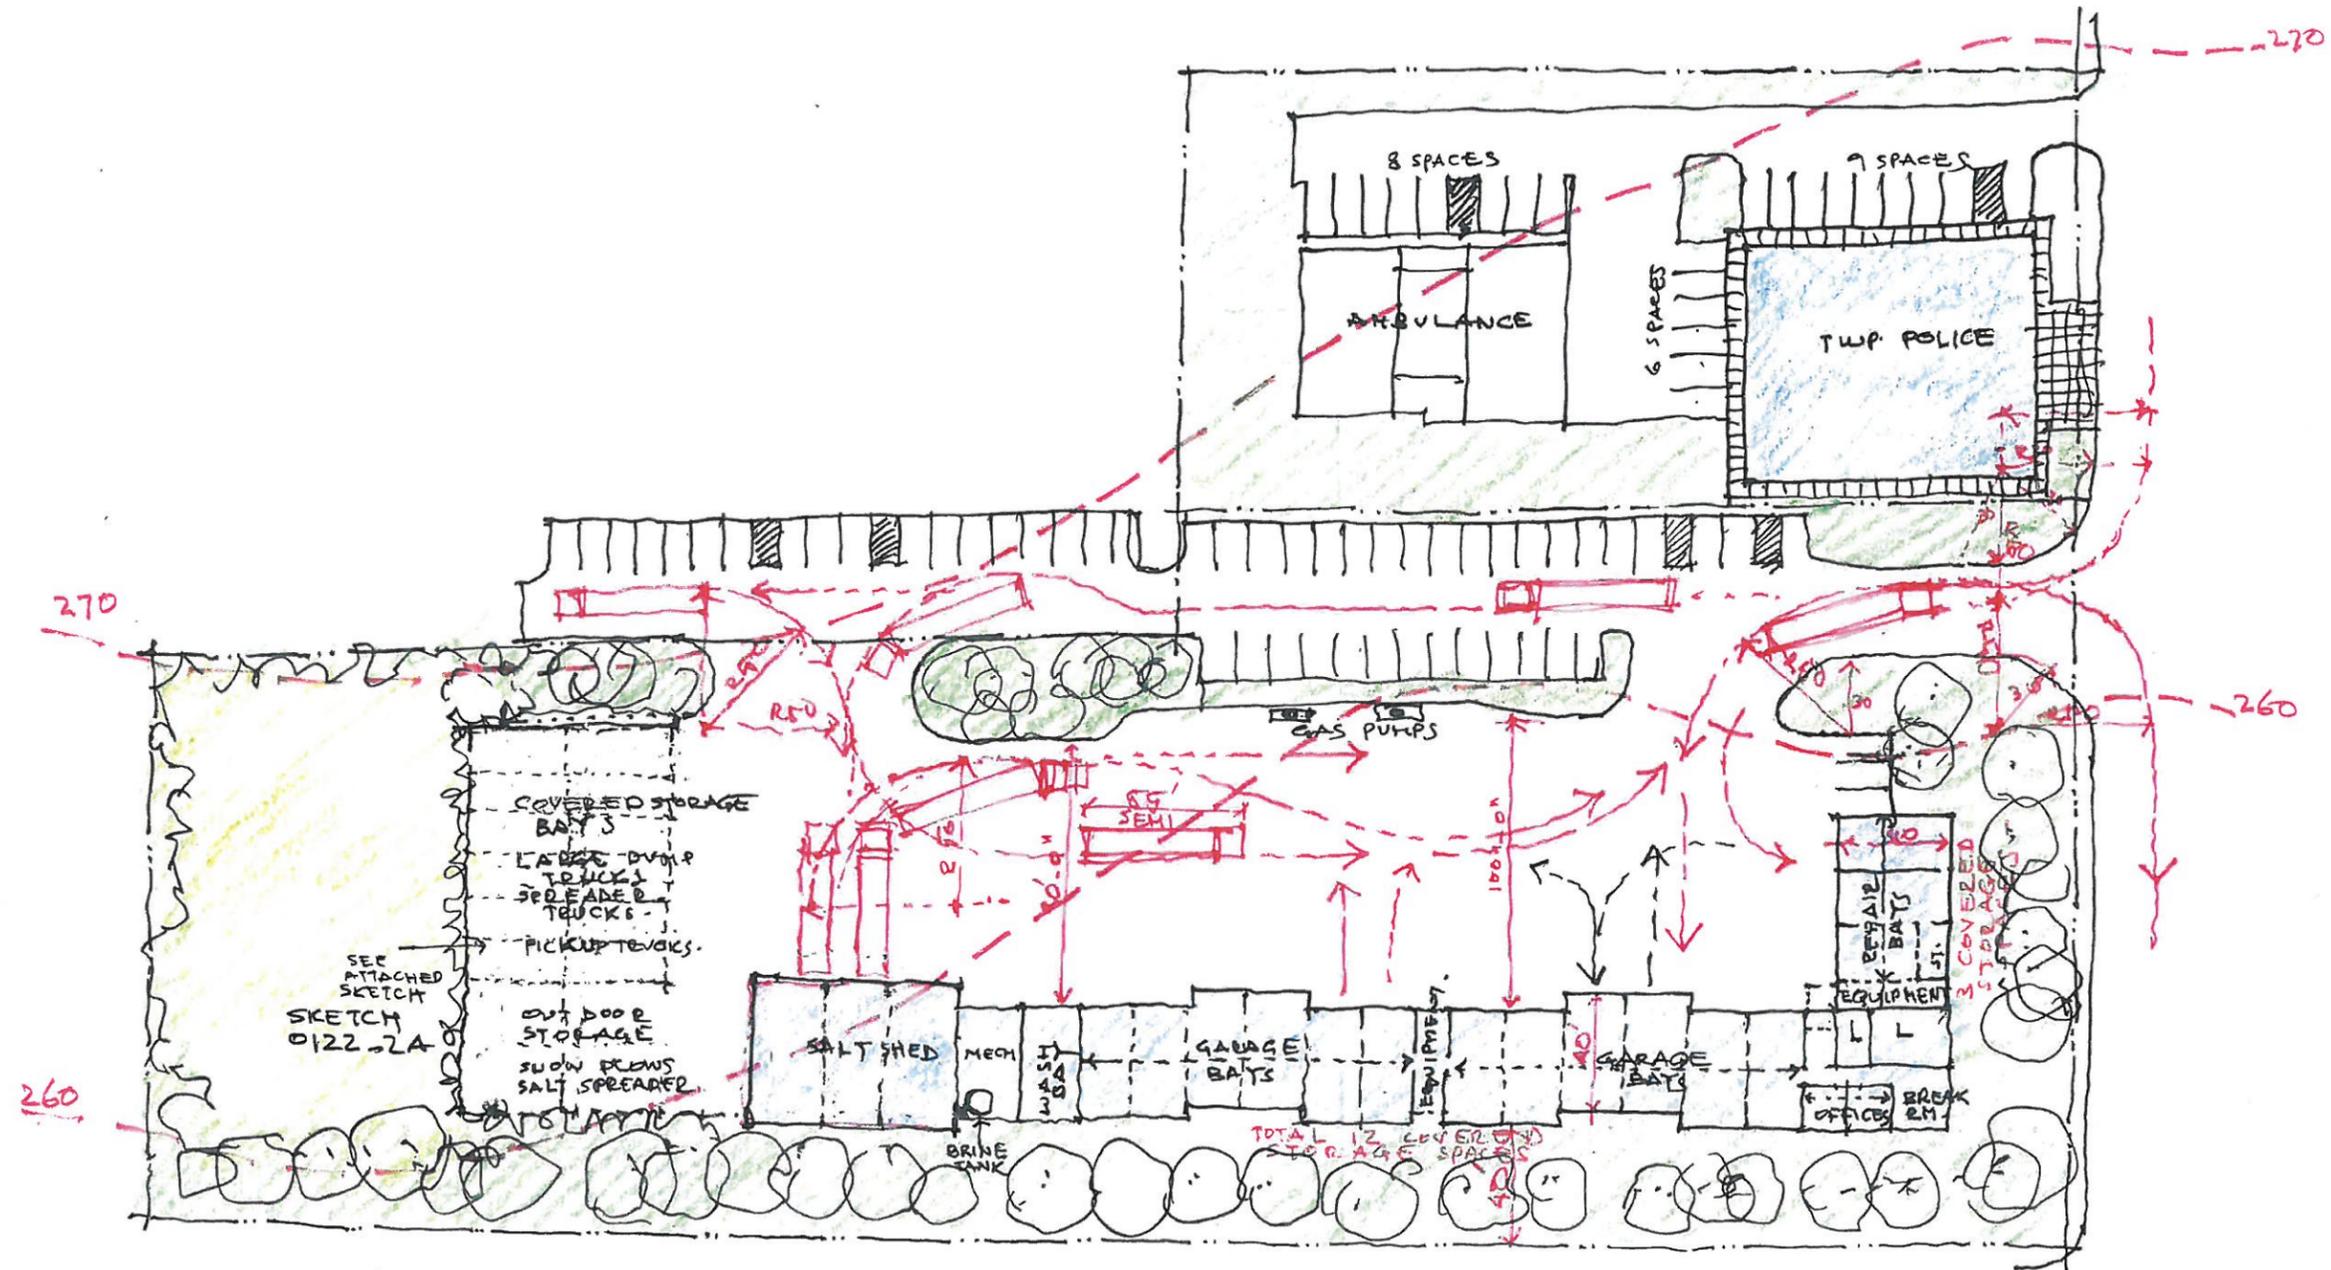
PARTIAL SITE PLAN
ALTERNATE SCHEME
SC' 1:50"=1'-0" PUBLIC WORKS/POLICE

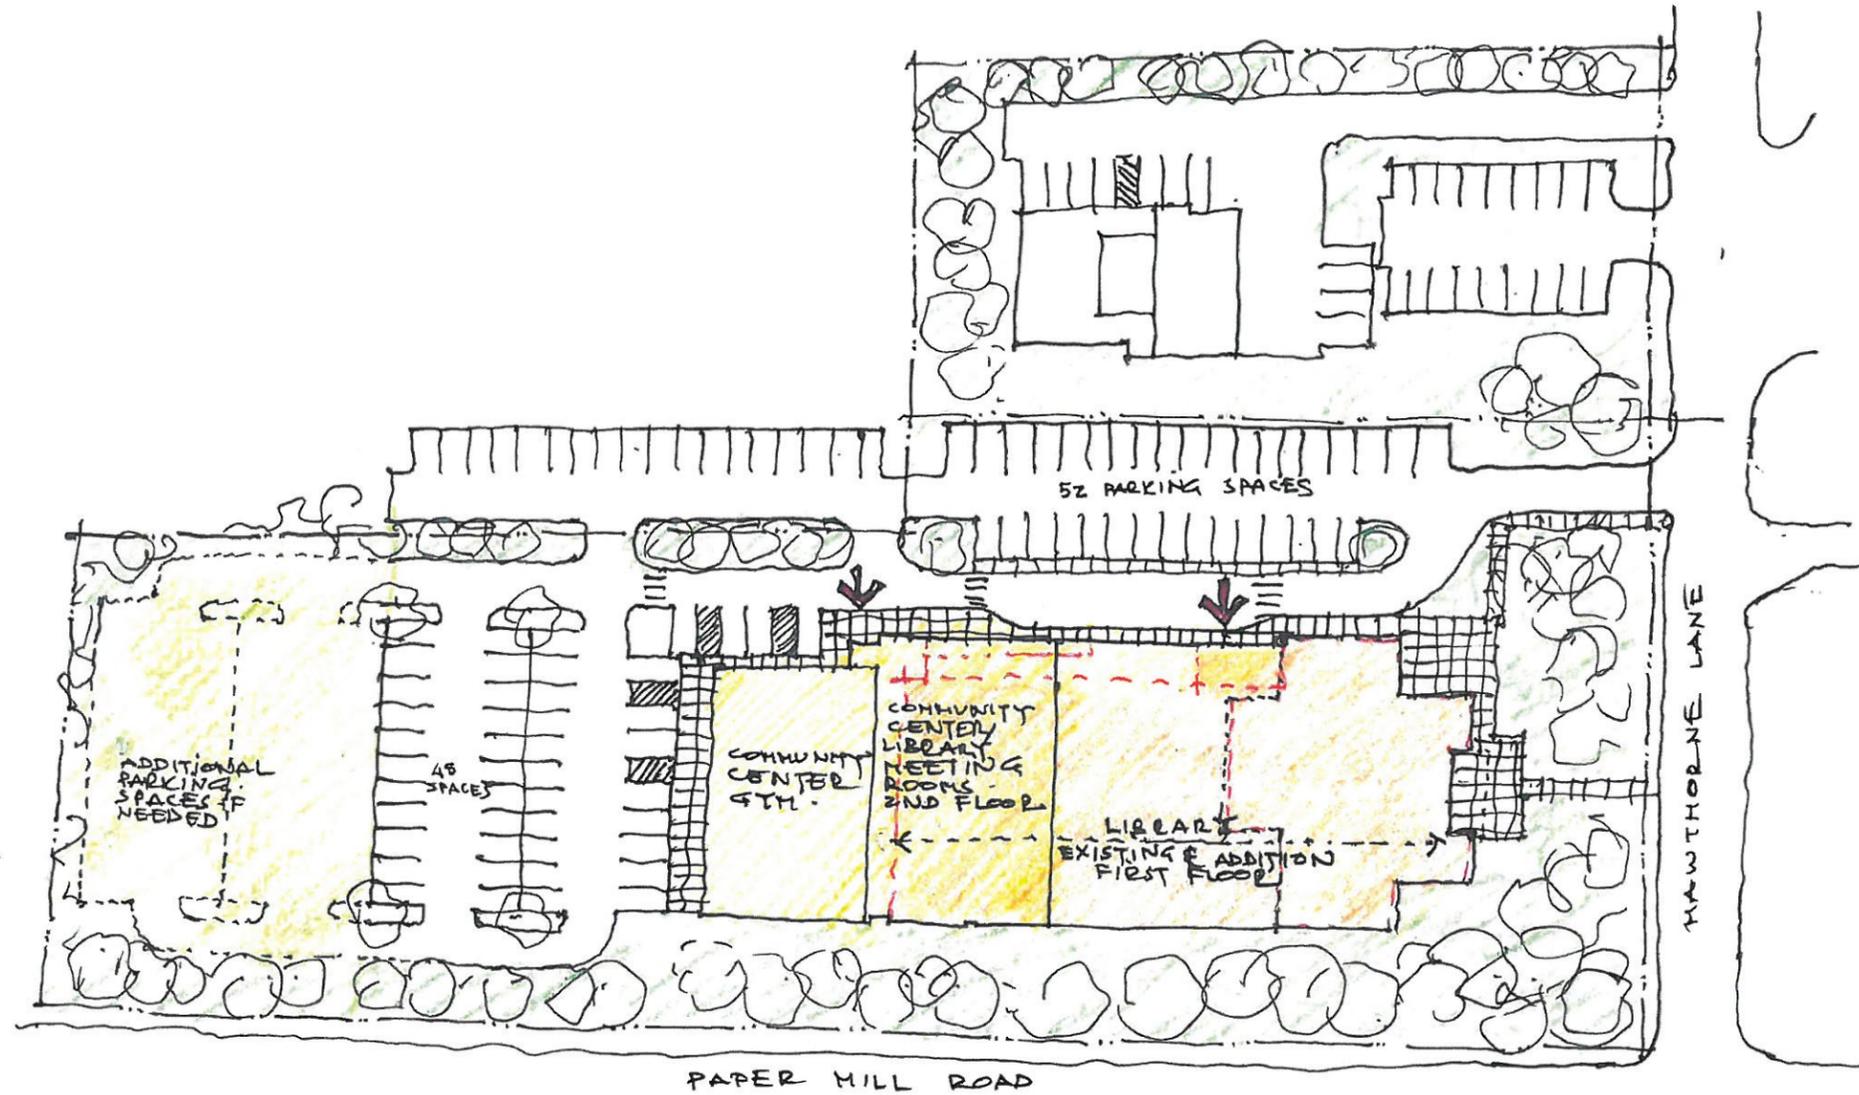
PARTIAL FLOOR PLAN
SC. 1:60 = 1'-0"

LIBRARY & COMMUNITY CENTER

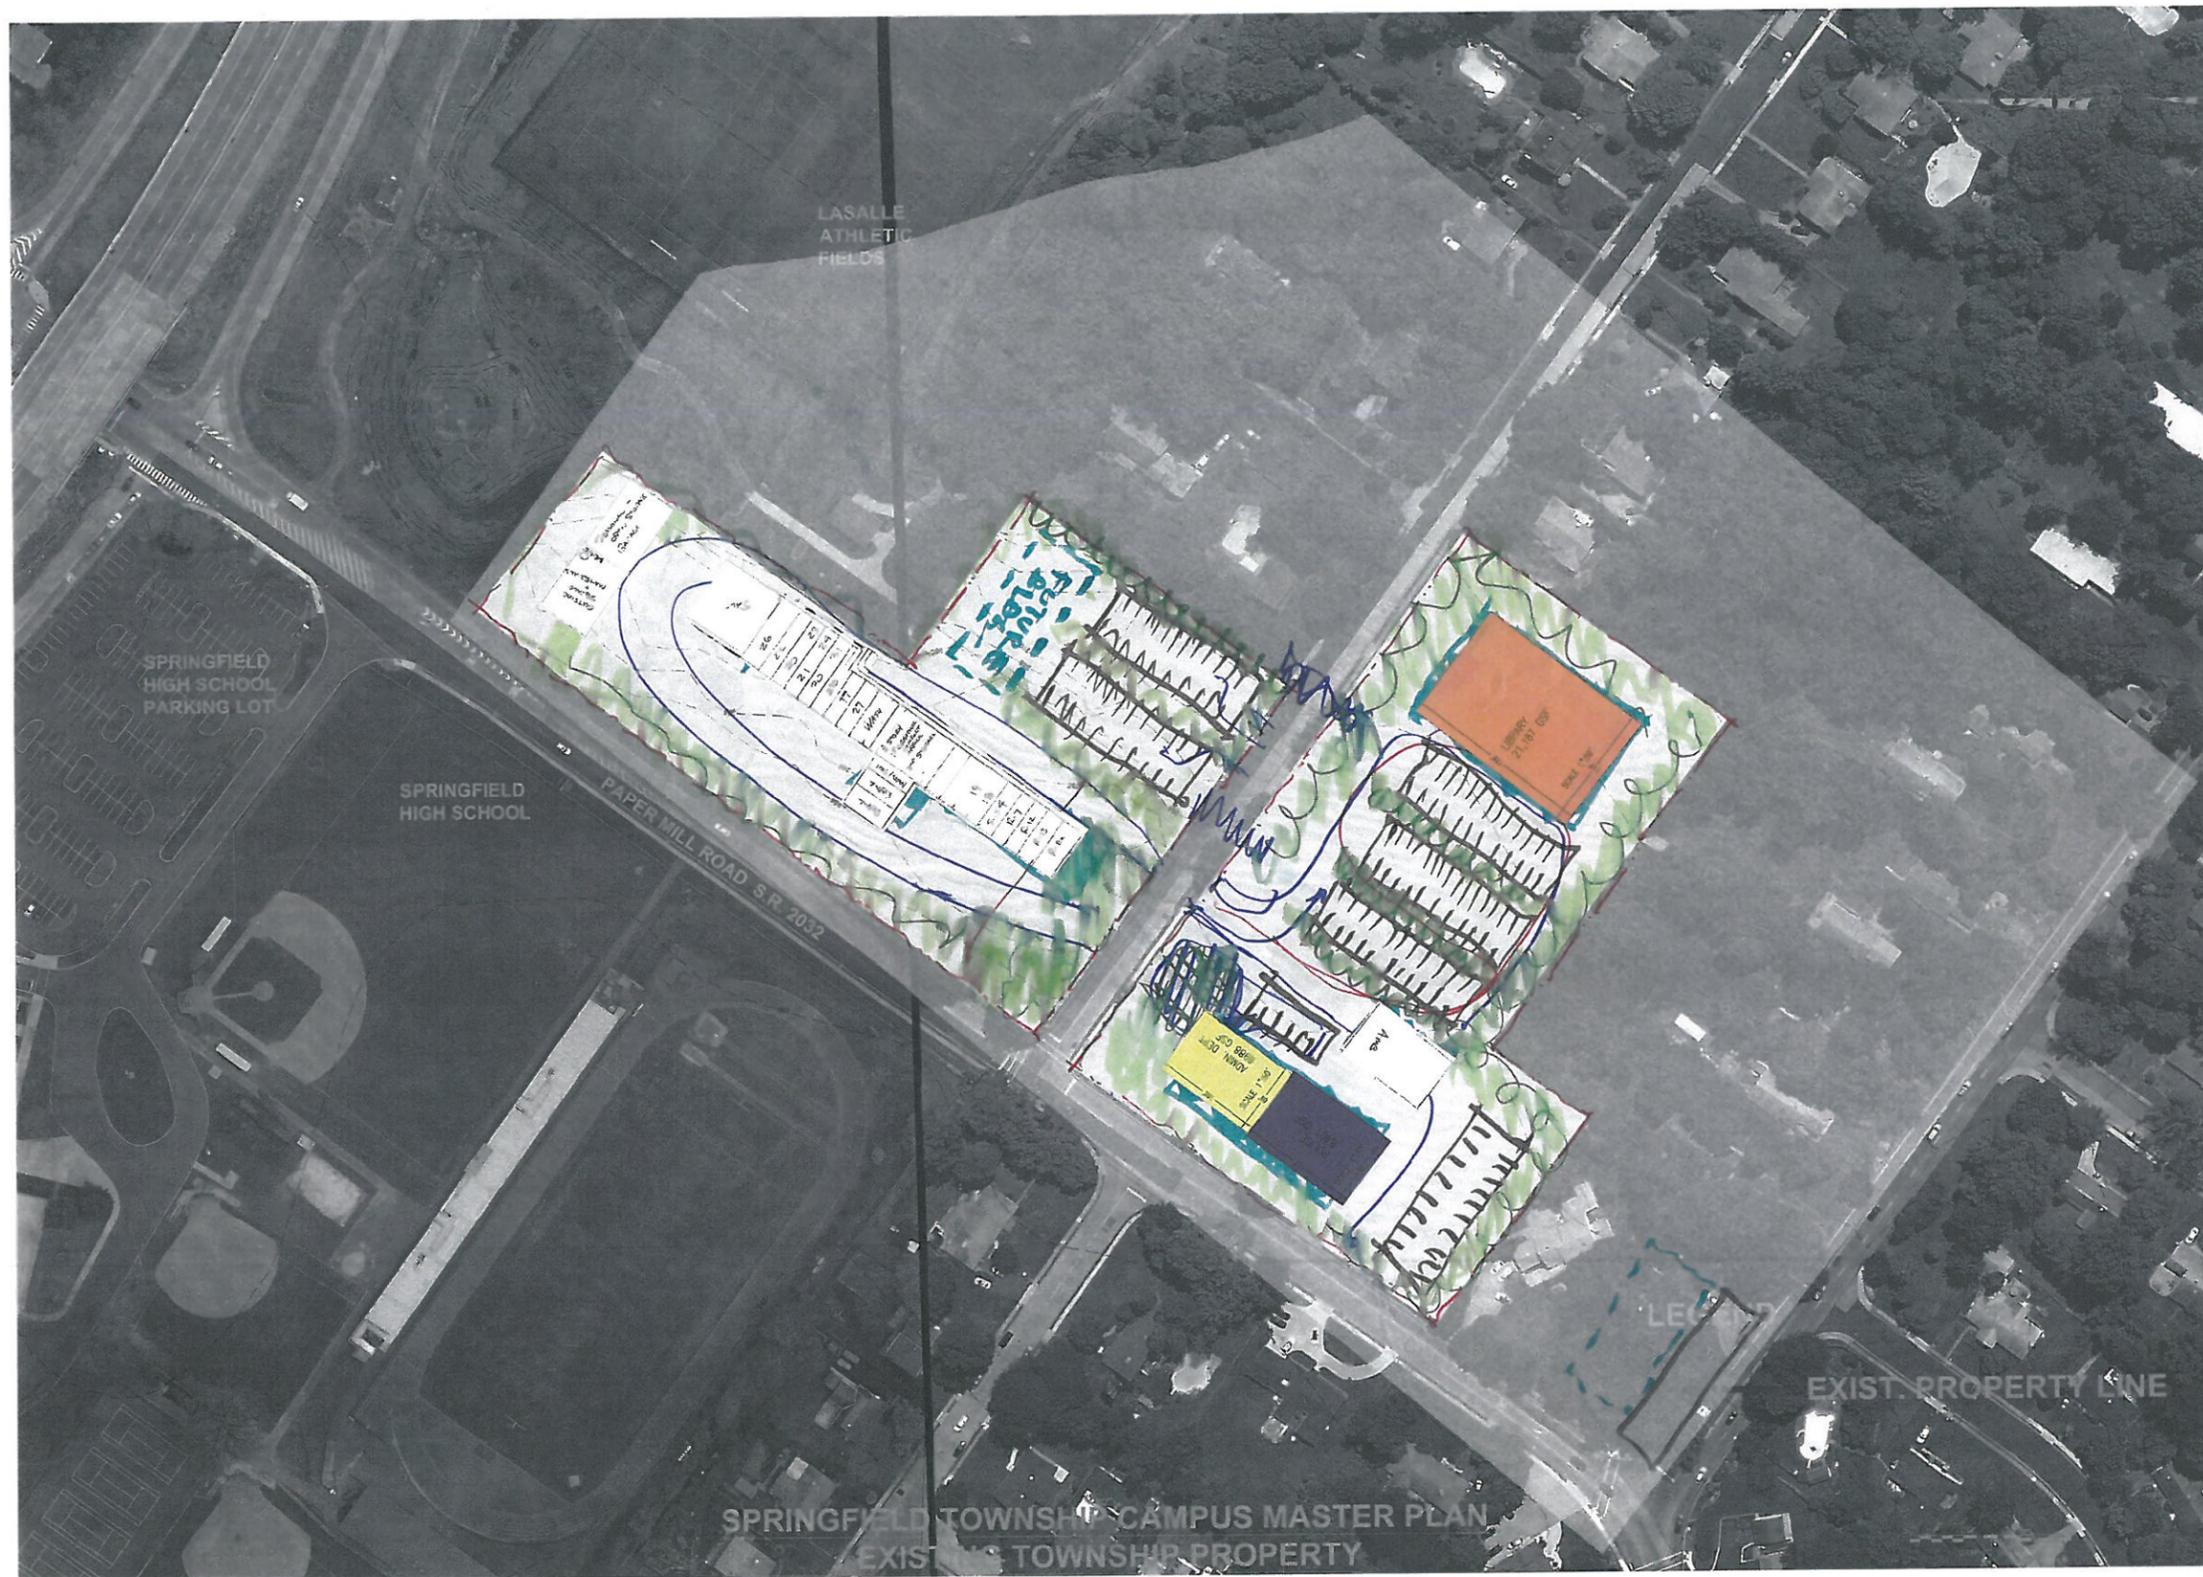
Sites Public Works on the site north on Paper Mill Road. It would be linear to Paper Mill Road but facing the road and set back from it. Administration would remain with the Police and the Library would be to the east of the current Public Works. A large multi-purpose building is placed in the rear of the property along Hawthorne Lane for the Library and the Community Building. Police would have a separate building on the current Library site.

SPRINGFIELD TOWNSHIP MUNICIPAL CAMPUS MASTER PLAN APRIL 2013 CONCEPTS
