RE: SPRINGFIELD TOWNSHIP MUNICIPAL CAMPUS MASTER PLAN

VITETTA Architects and Engineers is proud to forward our summary report and recommendations for the Springfield Township Municipal Campus Master Plan. This report summarizes our work with the Township and the Advisory Committee to review the previously prepared plan and help developed a consensus plan for how best to meet the now and future needs of the Township government and its ability to provide services to the Township.

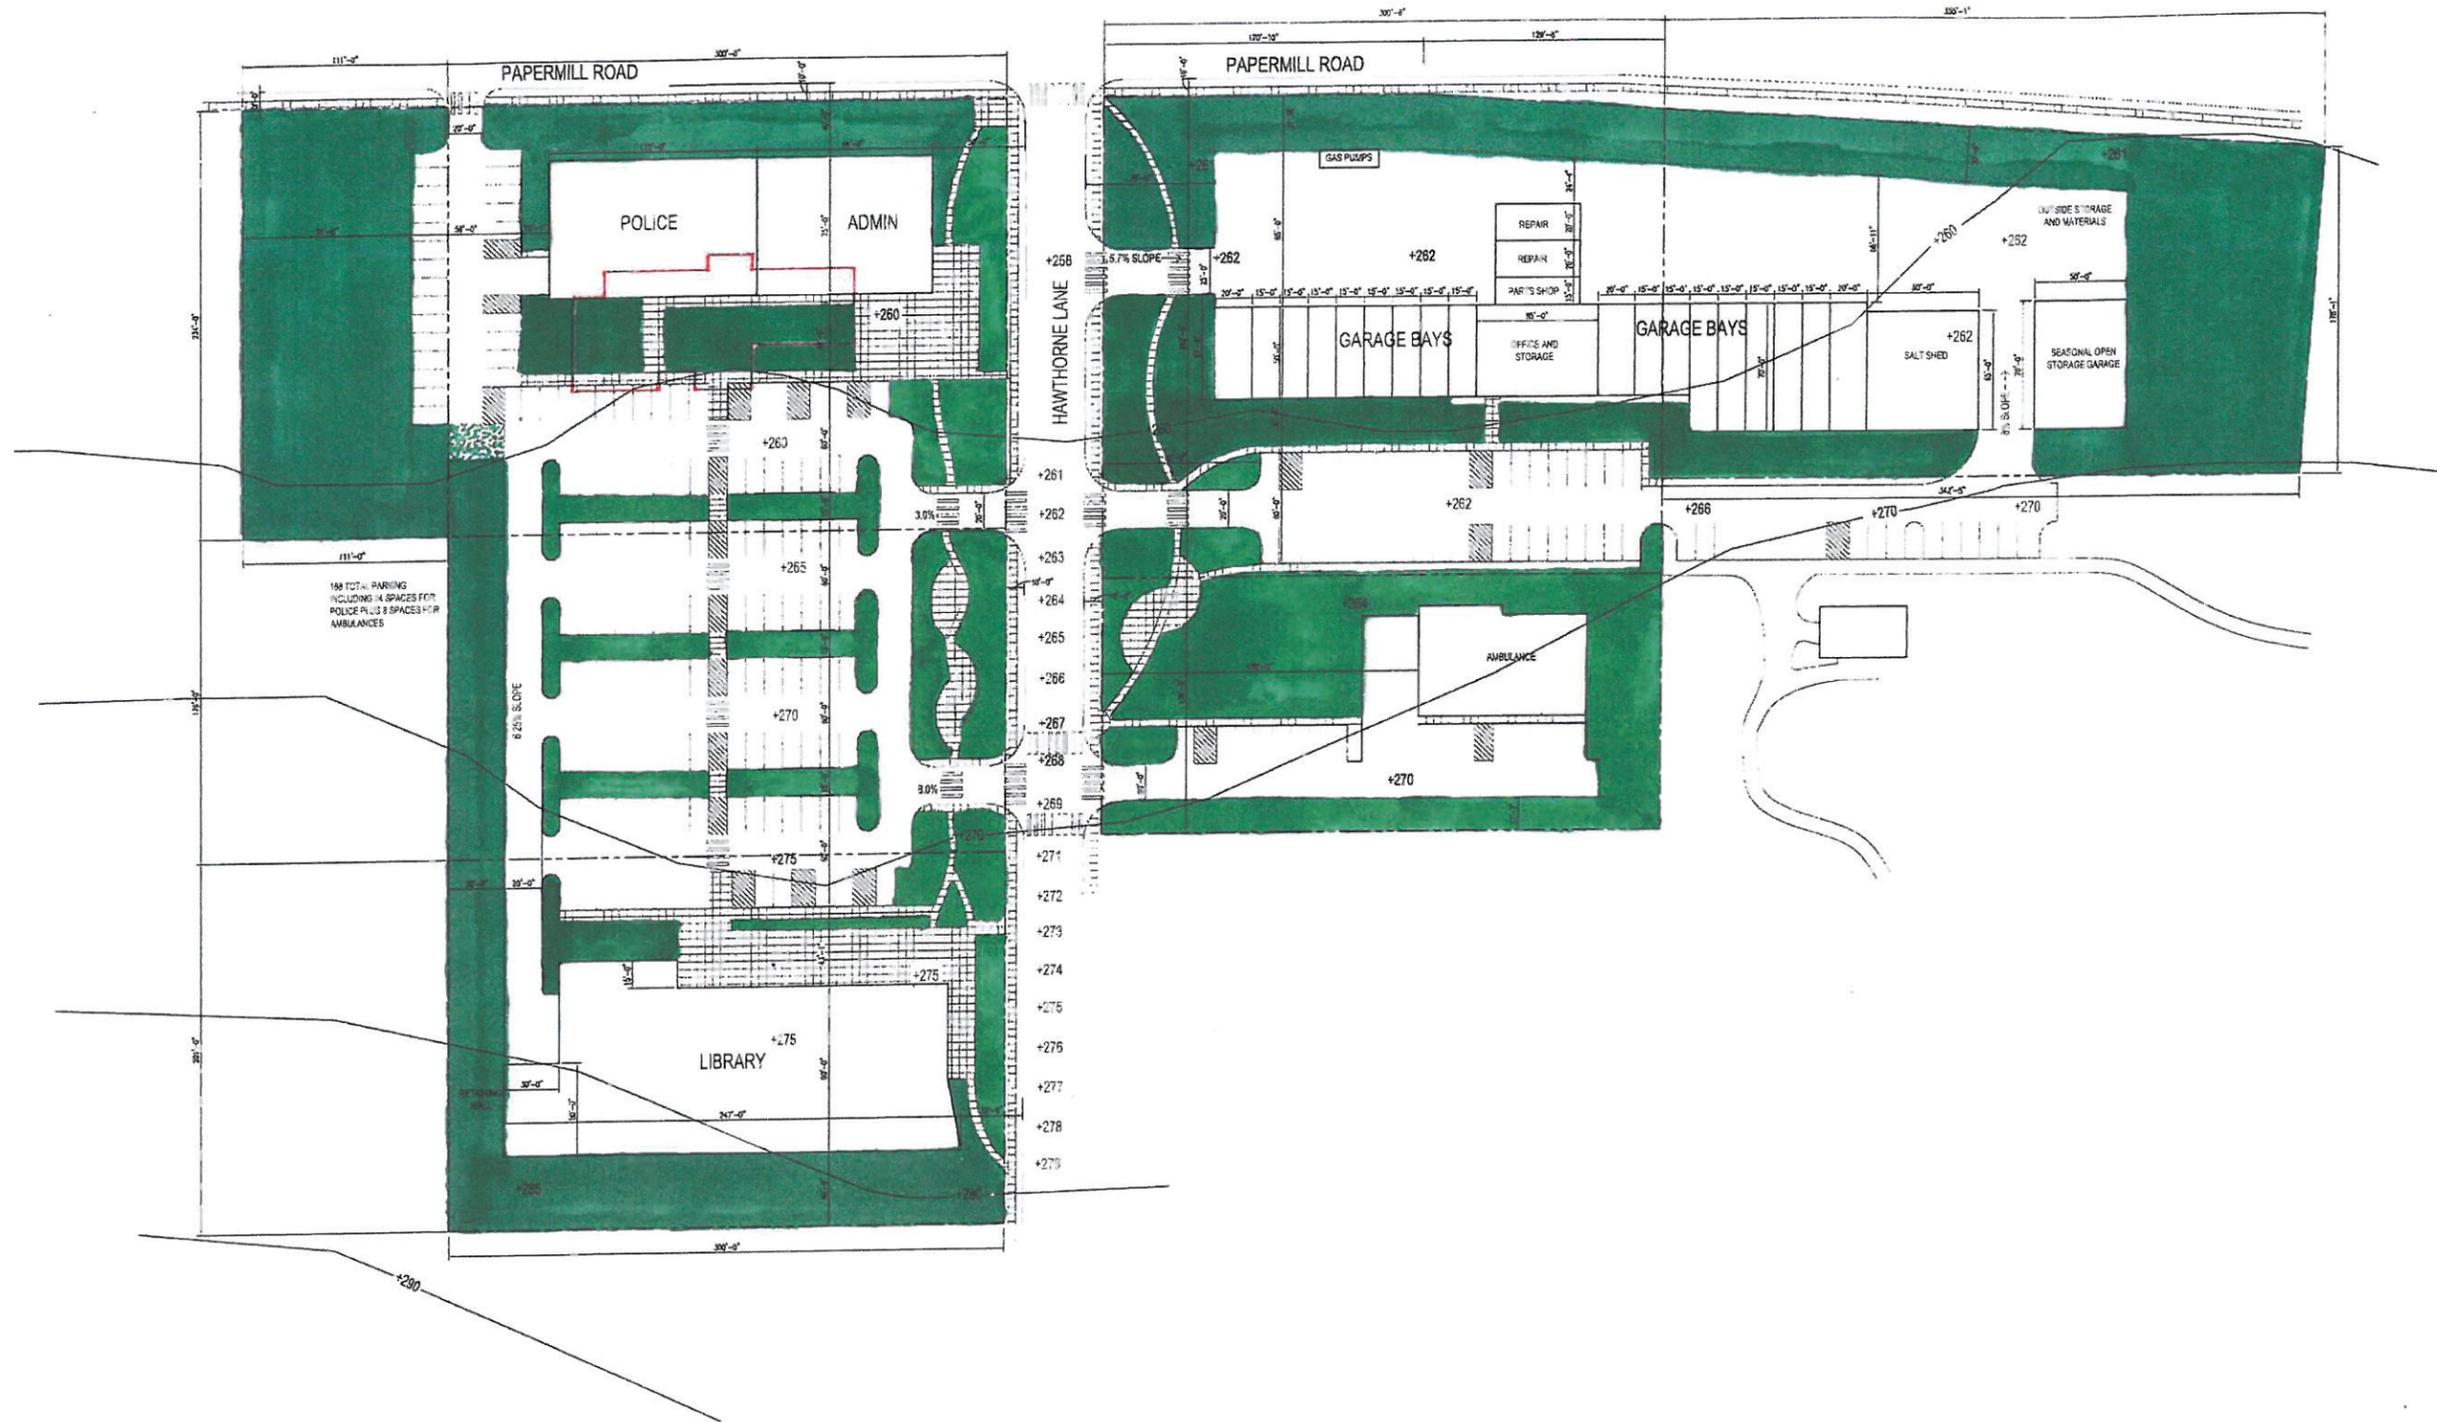
The 4-24-12 Site plan with site sections to show the parking area slopes and proposed rain garden features.

SITE PLAN VIEW
